# REPAIR GUIDELINE

Line trimmer \_STX3800

*Version: 1*

*Issue Date: 01/11/2019*

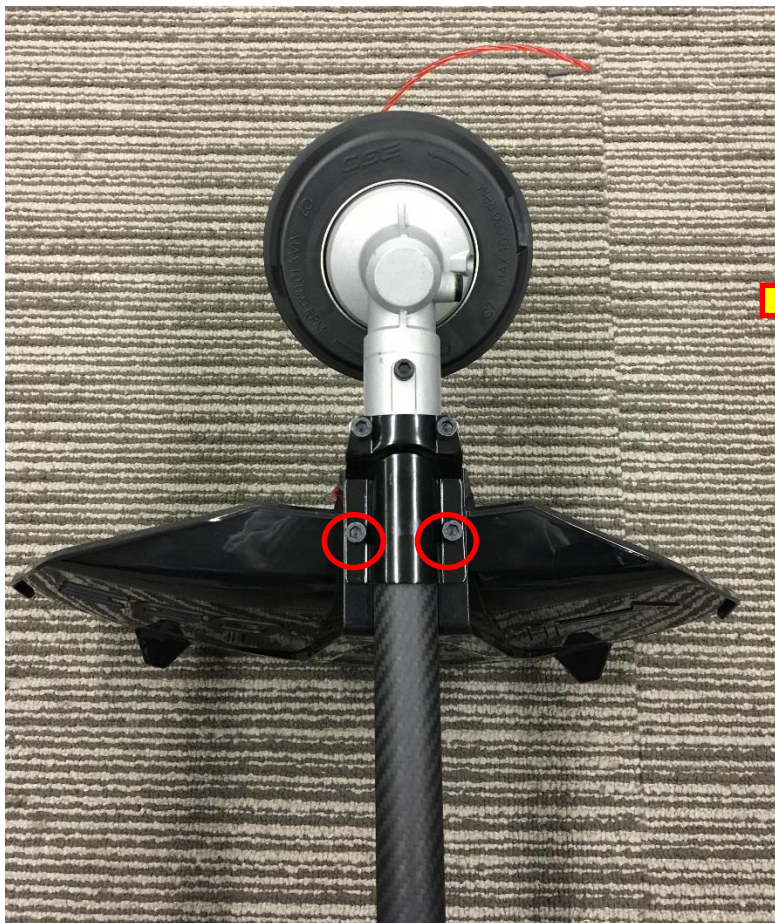
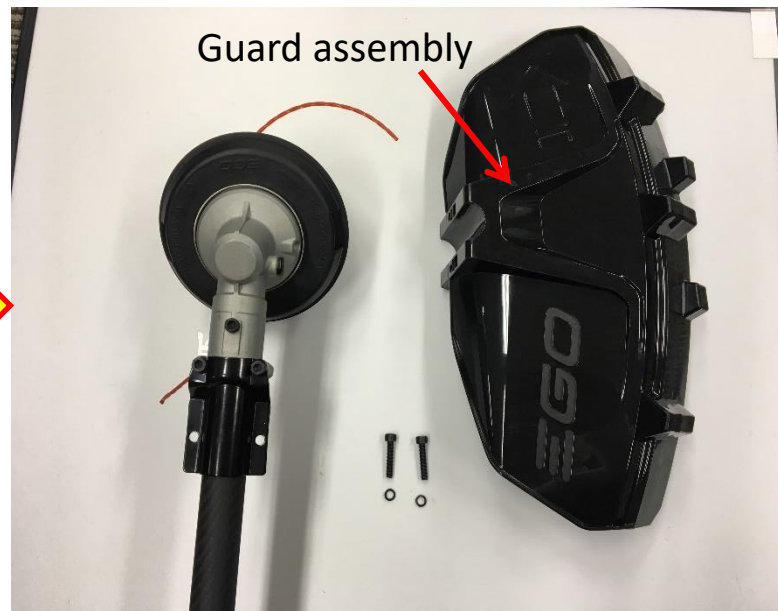
1. Loosen 2 screws to disassemble the guard assembly, if the guard assembly is broken, replace it with a new one.

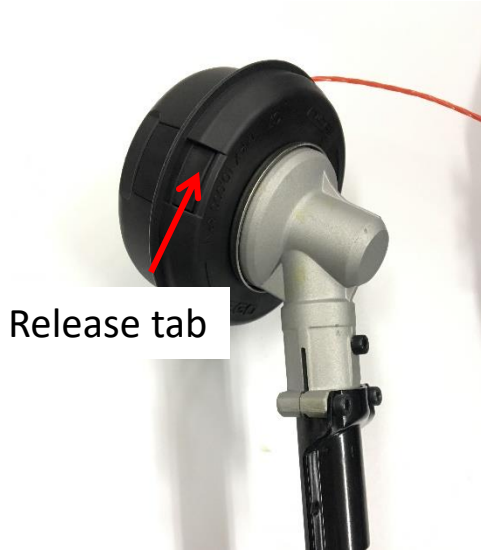
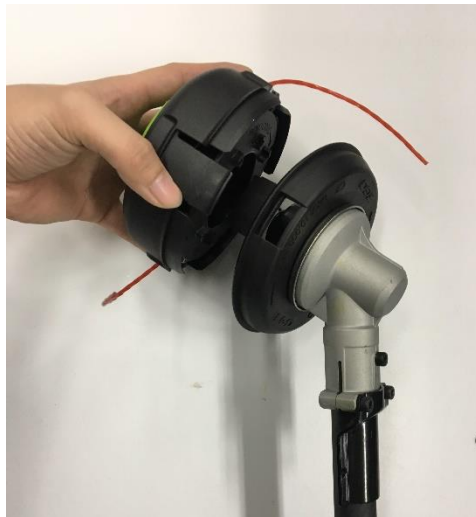
2. Press the release tabs to remove the lower housing assembly & mounting wire holder ASSY.

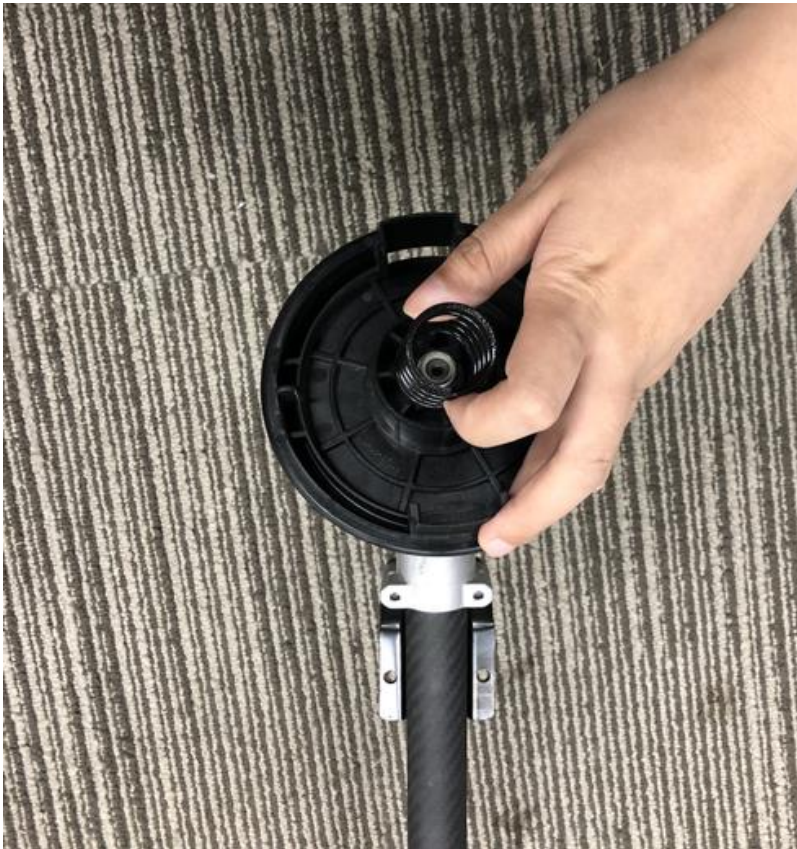
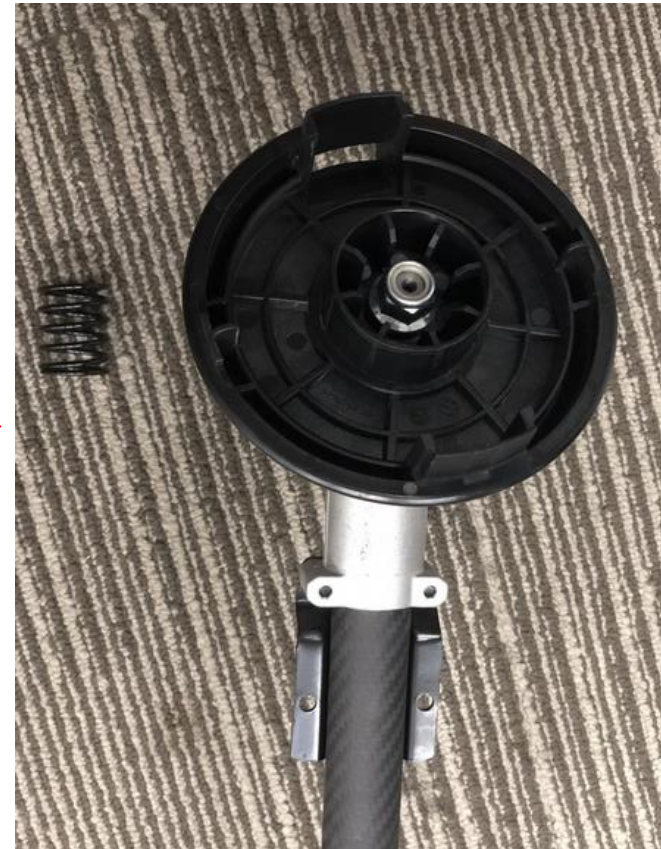
3. Take the spring out of the upper housing assembly.

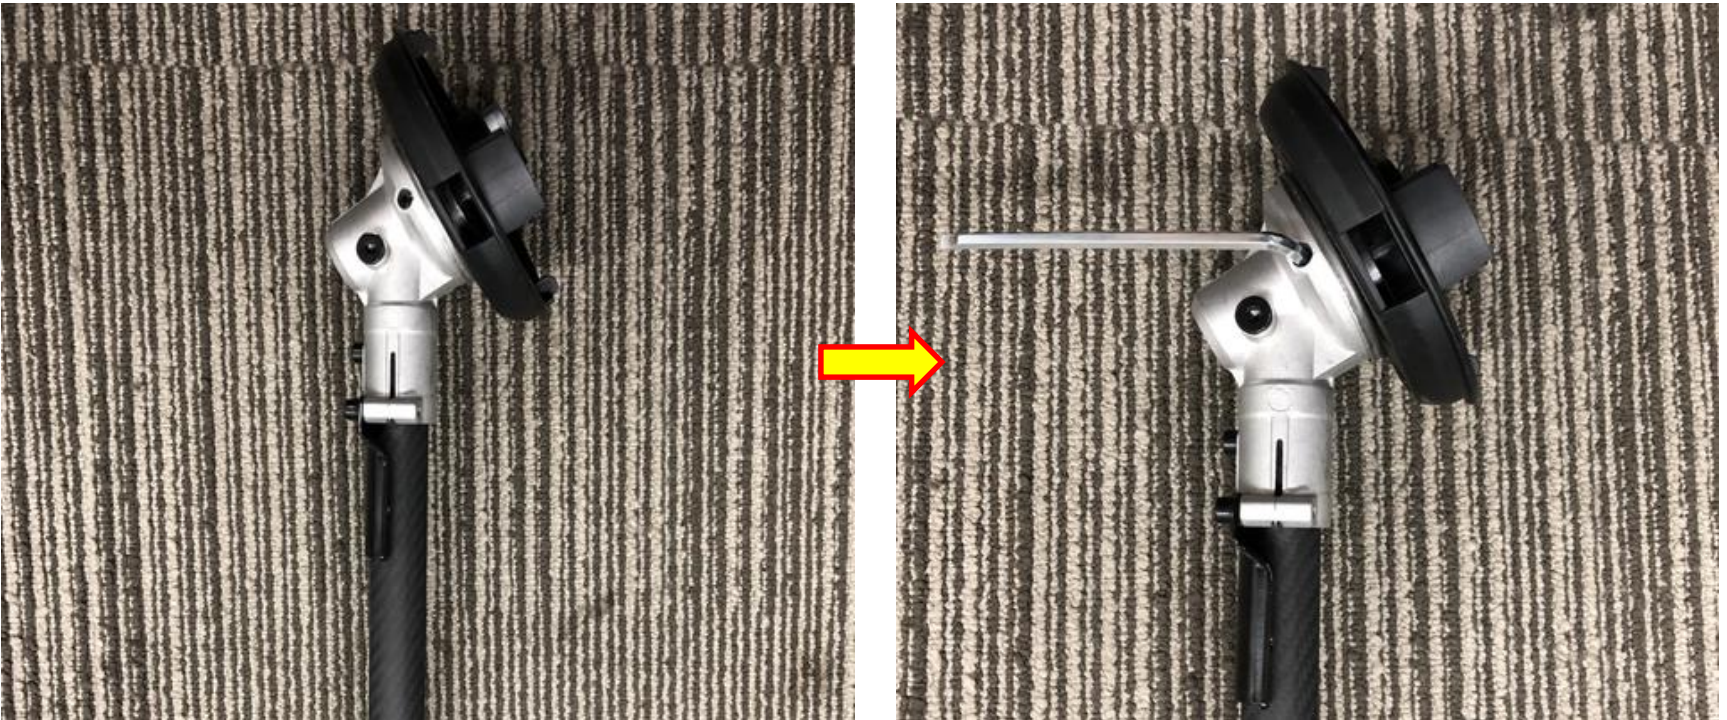
4. Rotate the upper housing assembly to align the slot in the flange with the hole in the gear case.
5. Insert the hex wrench into the aligned holes to act as a stabilizer.

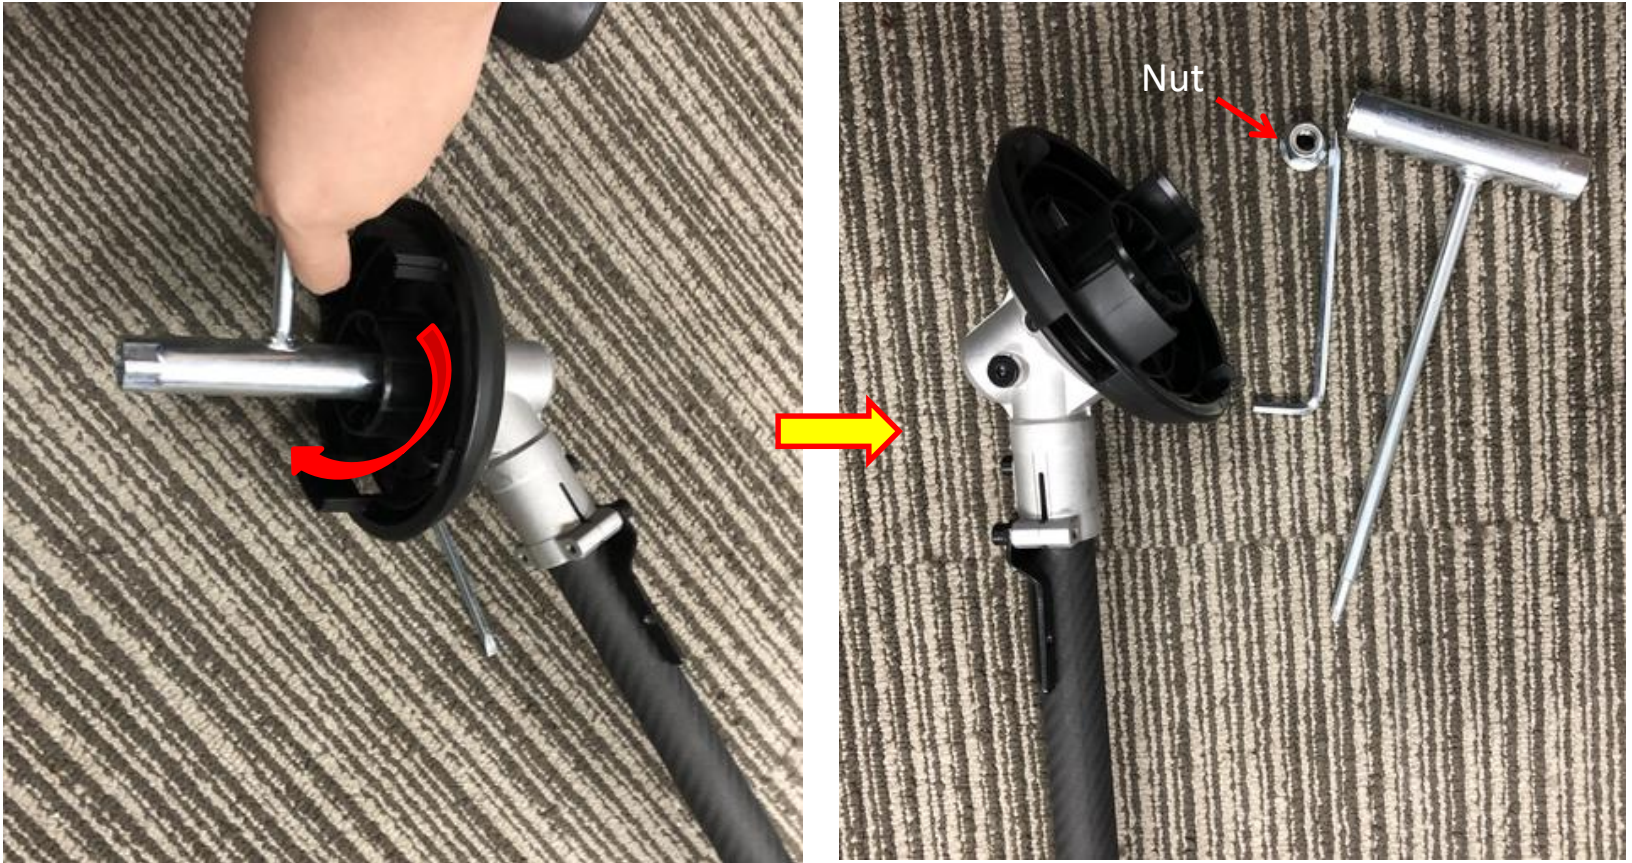
6. Loosen the nut with socket wrench clockwise to remove it from the shaft.

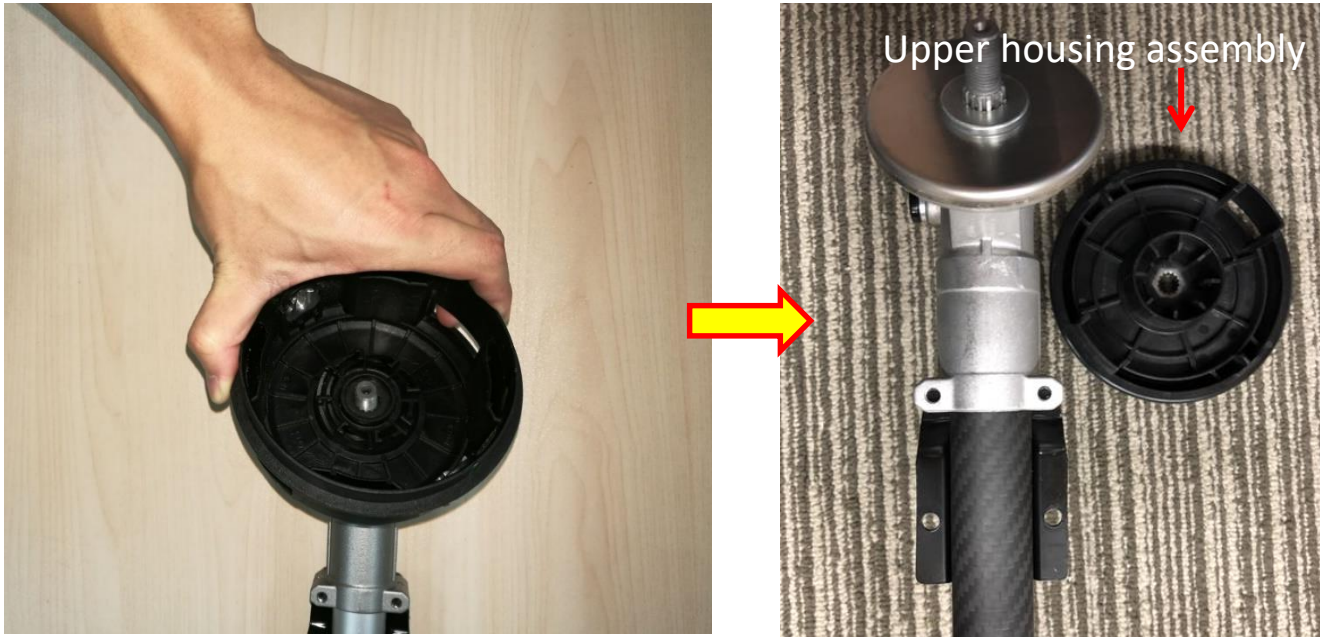
7. Take the upper housing assembly out of the shaft.

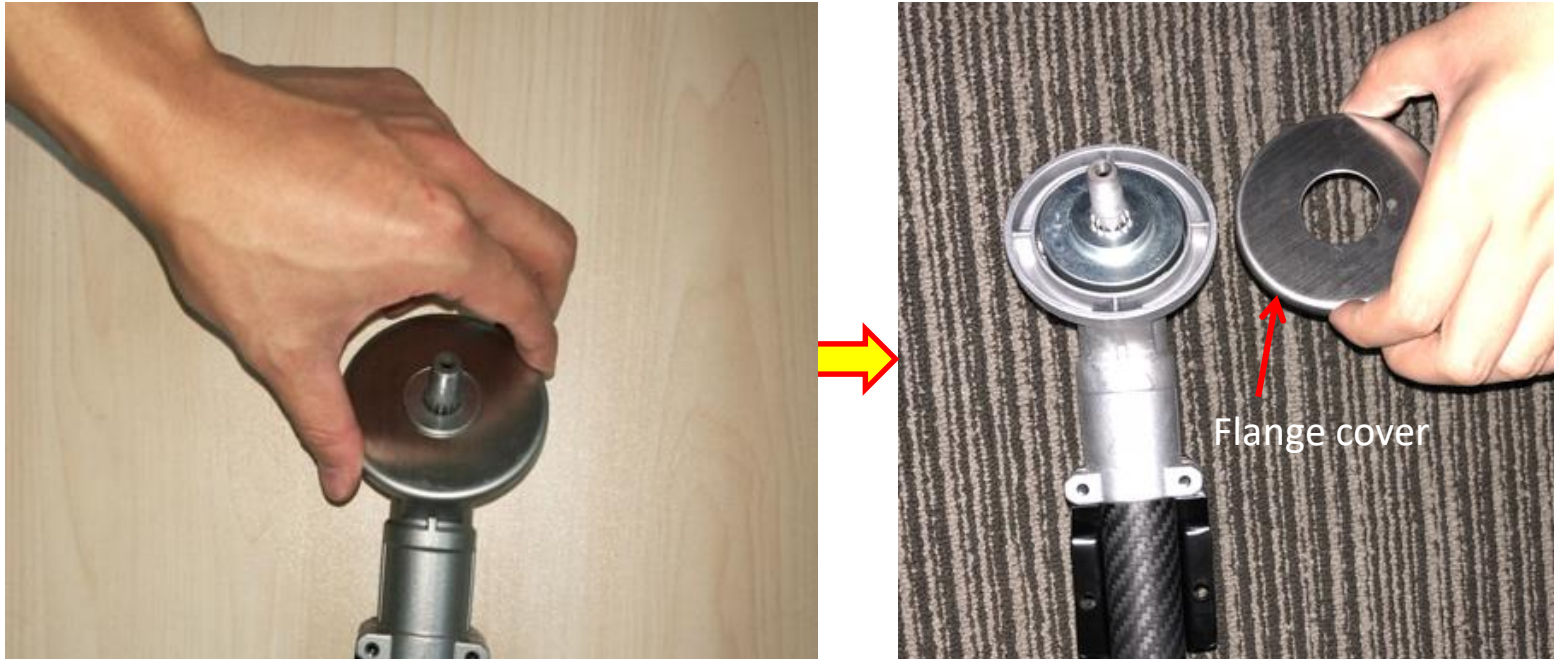
8. Take the flange cover out of the shaft.

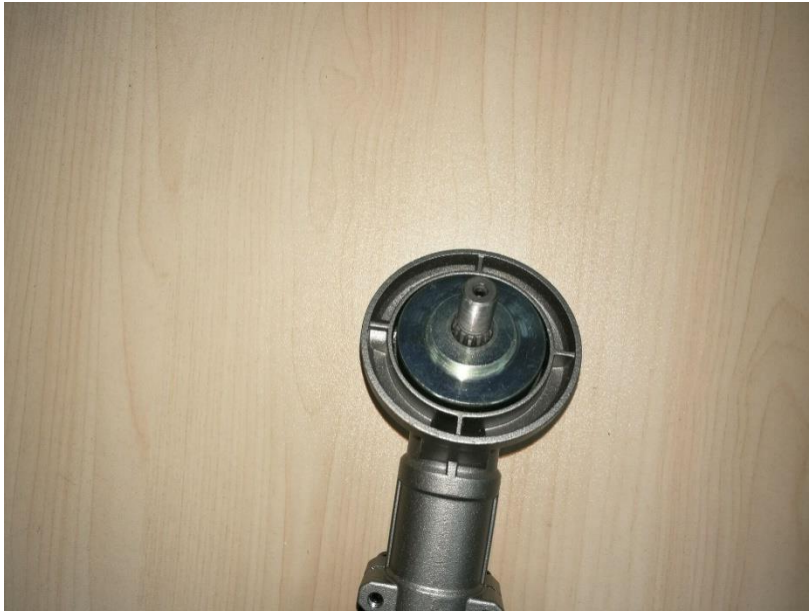
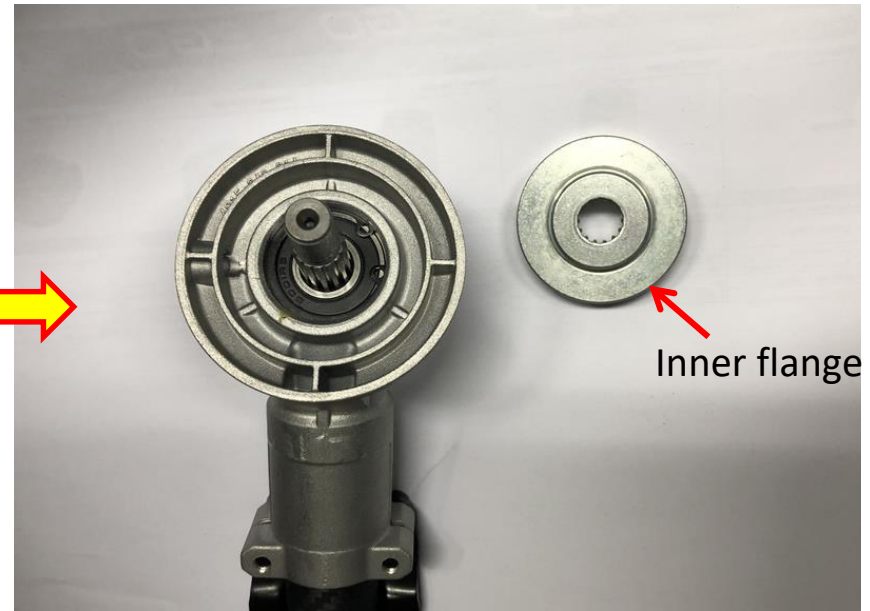
9. Take the flange out of the shaft.

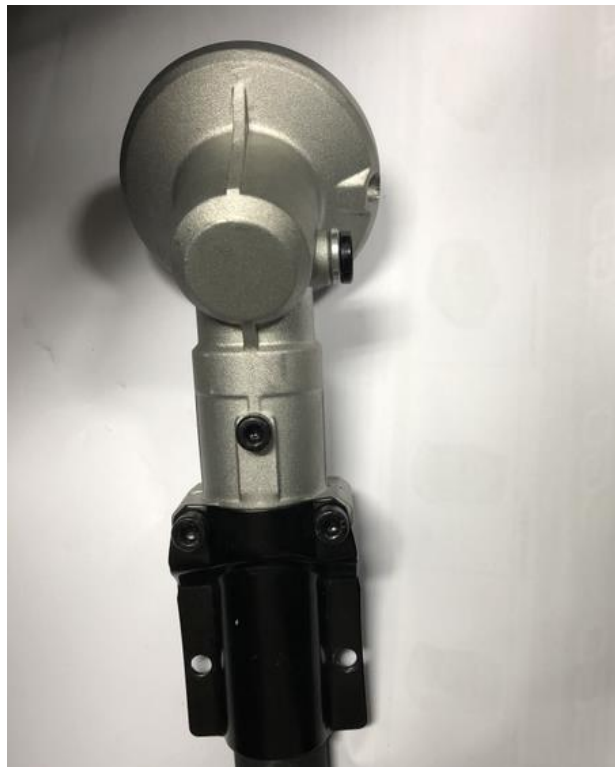
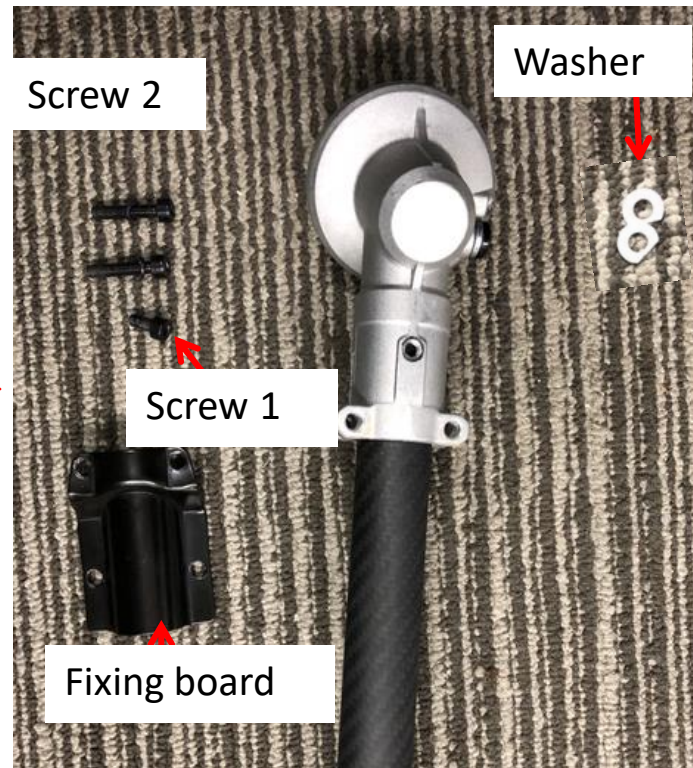
10. Loosen 3 screws to remove the fixing board.

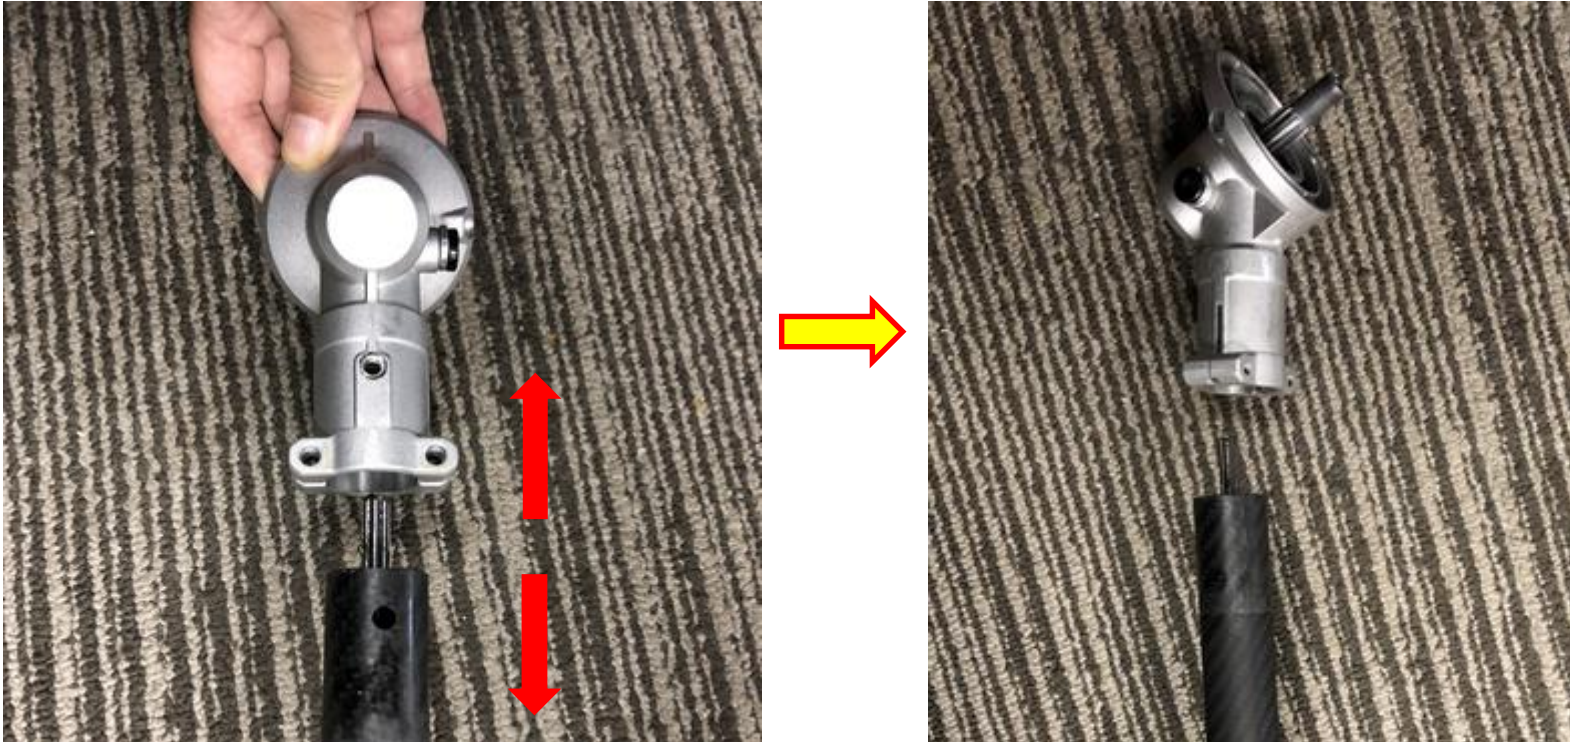
11. Pull the connecting tube with one hand and pull the gear case with the other hand to separate them from each other.

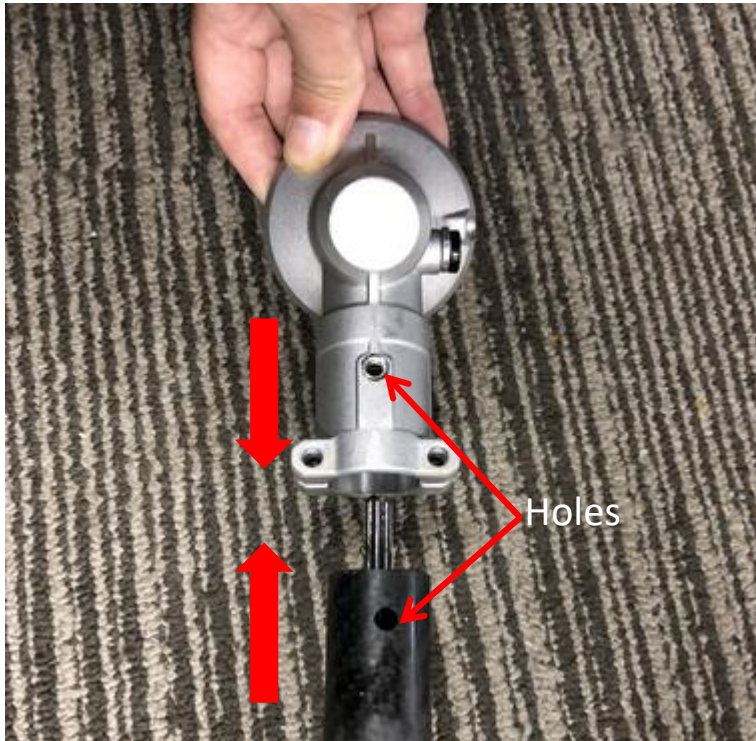
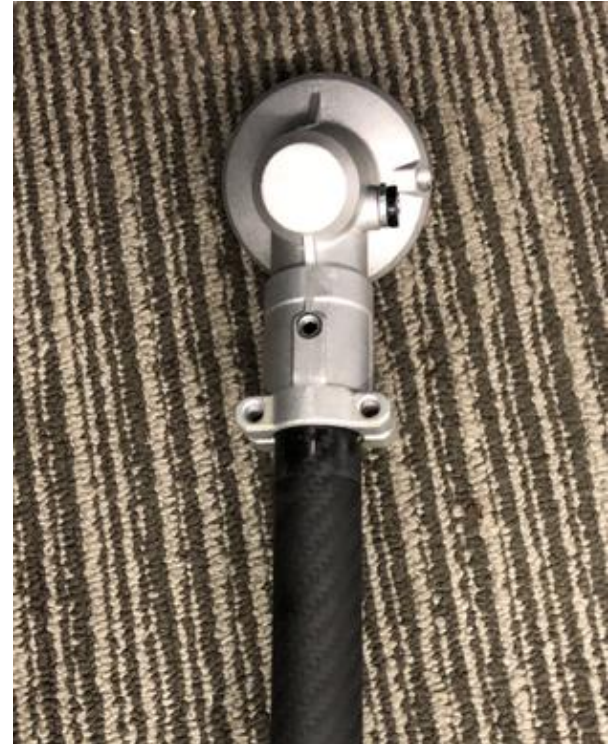
12. With the hole in the gear case aligned with the hole in the tube, reassemble them into place.

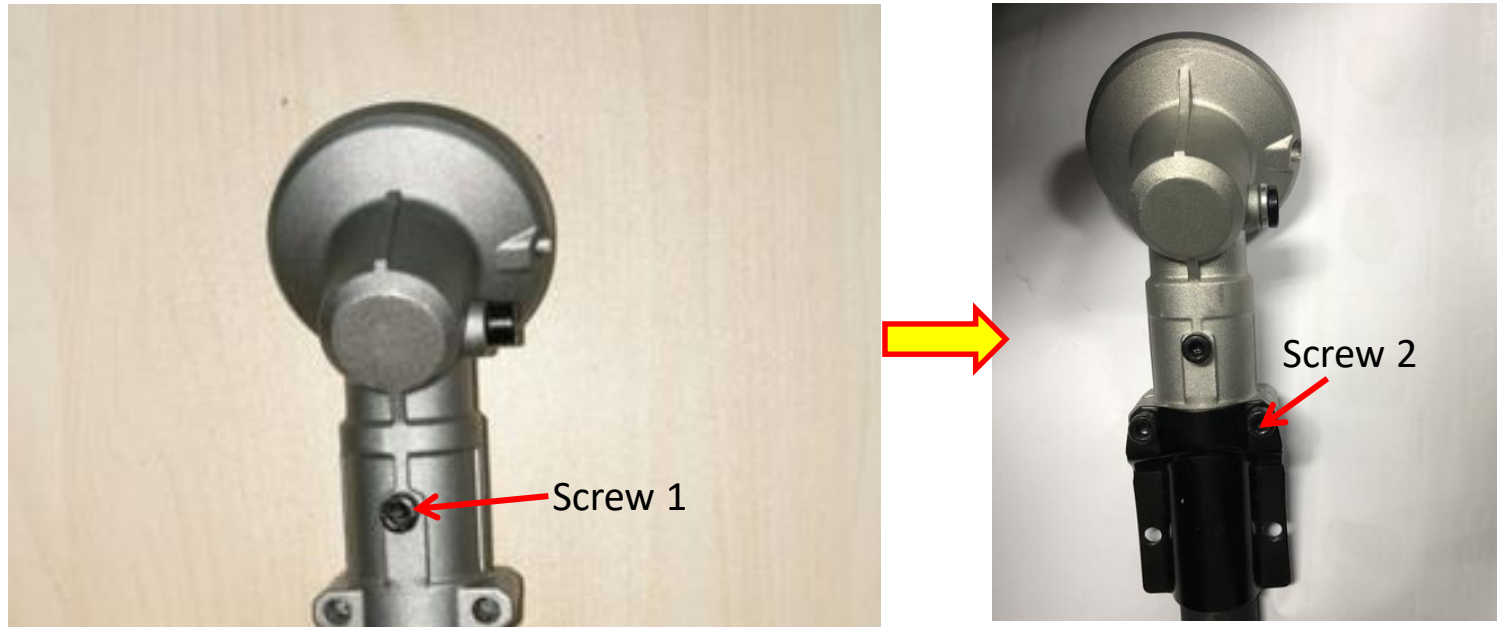
13. Tighten the gear case with the connecting tube with screw.
14. Tighten the fixing board with the gear case with screws.

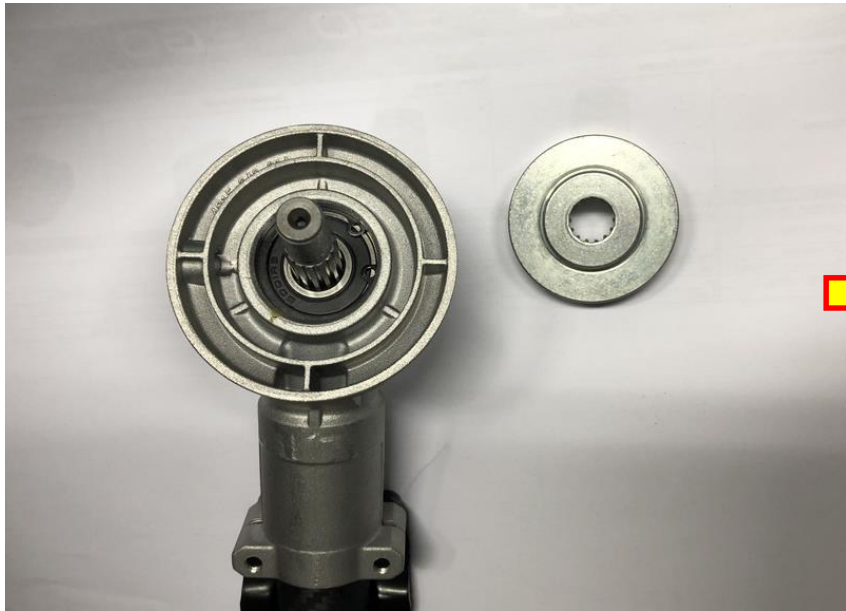
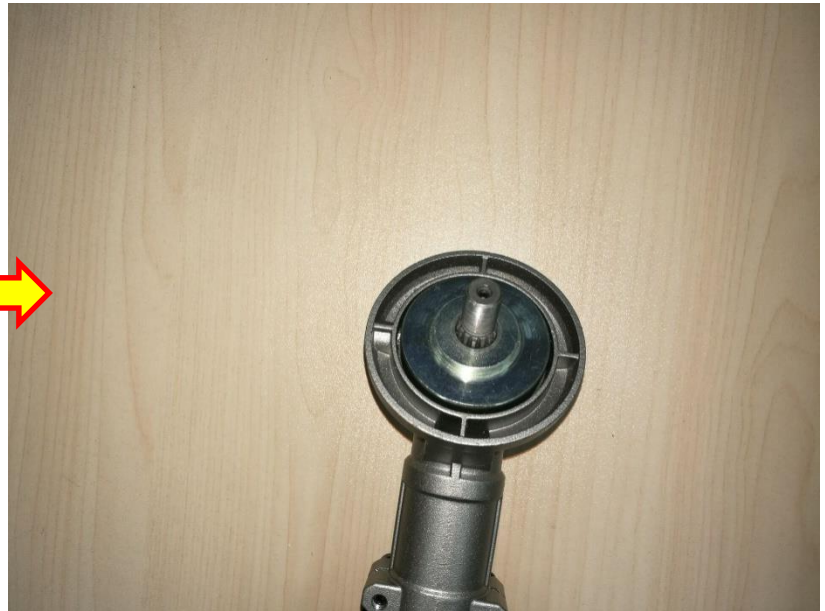
15. Mount the flange onto the shaft.

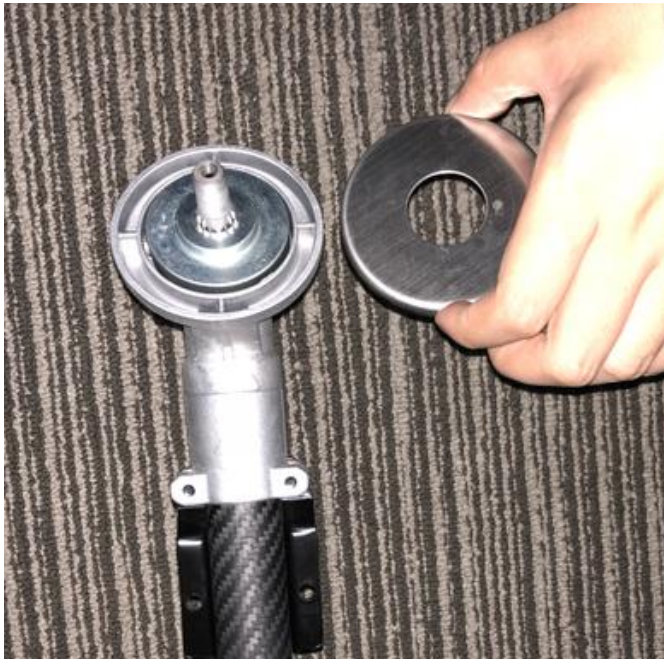
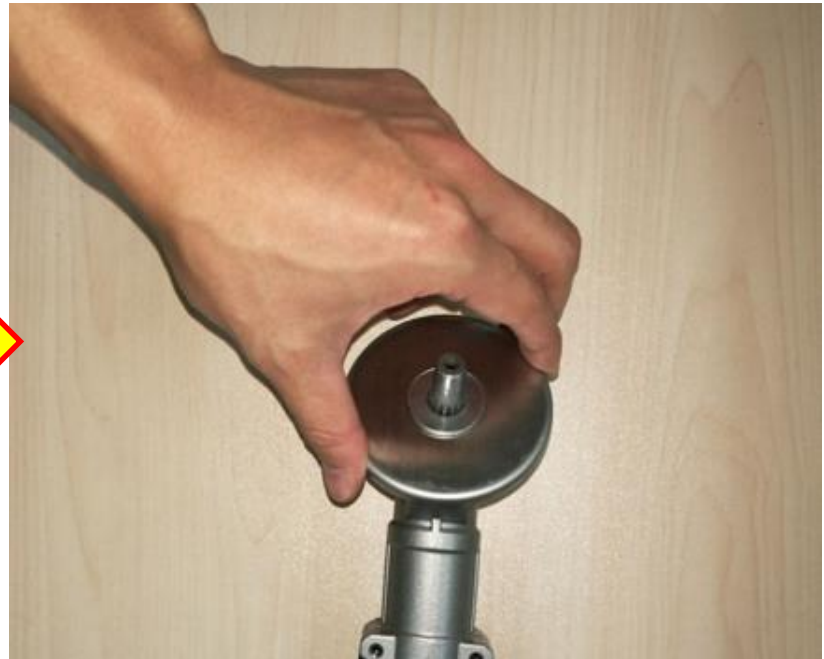
16. Mount the flange cover onto the shaft.

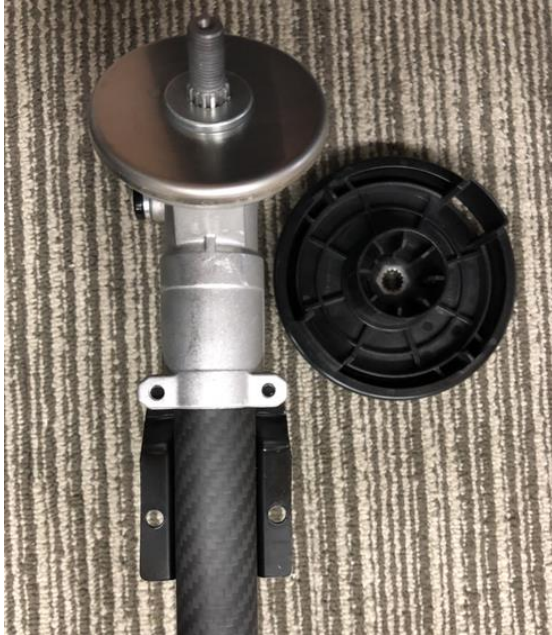
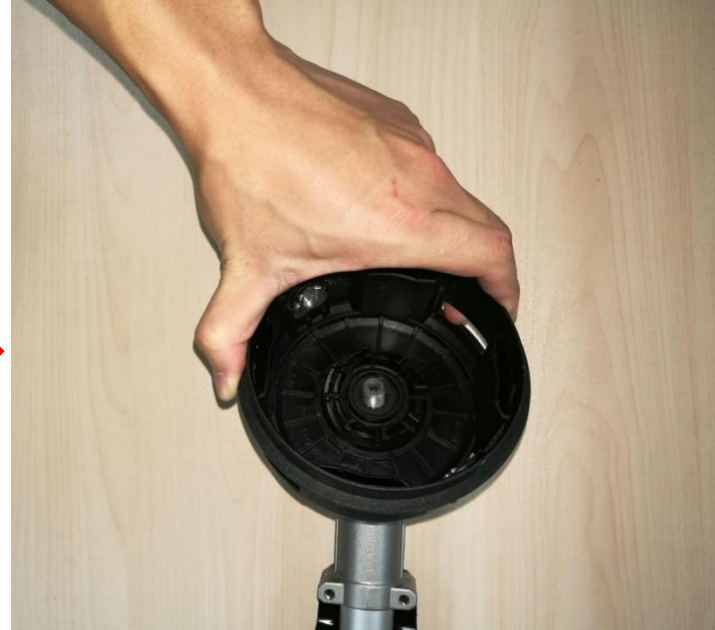
17. Mount the upper housing assembly onto the shaft.

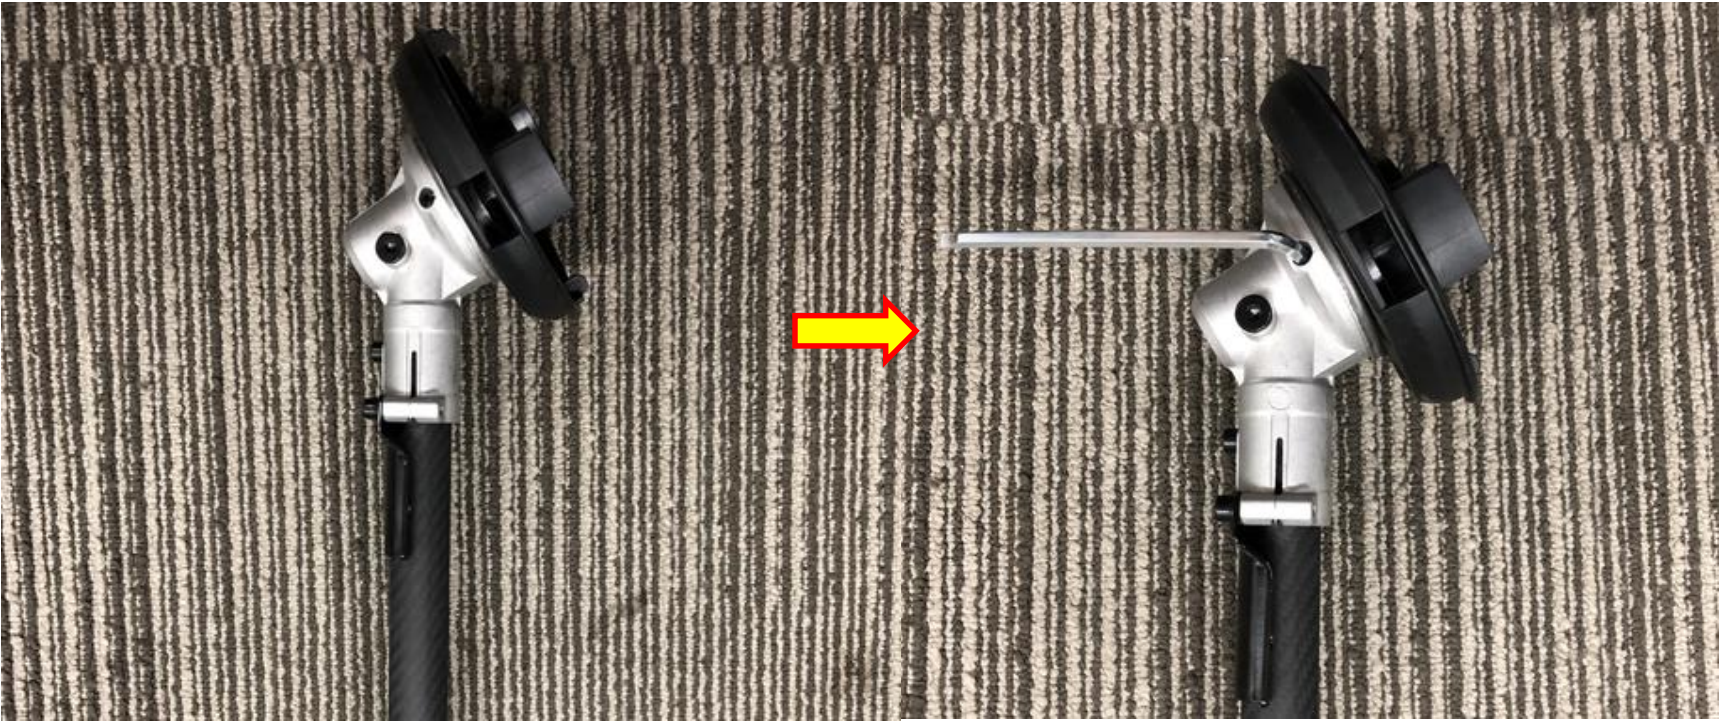
18. Rotate the upper housing assembly to align the slot in the flange with the hole in the gear case.
19. Insert the hex wrench into the aligned holes to act as a stabilizer.

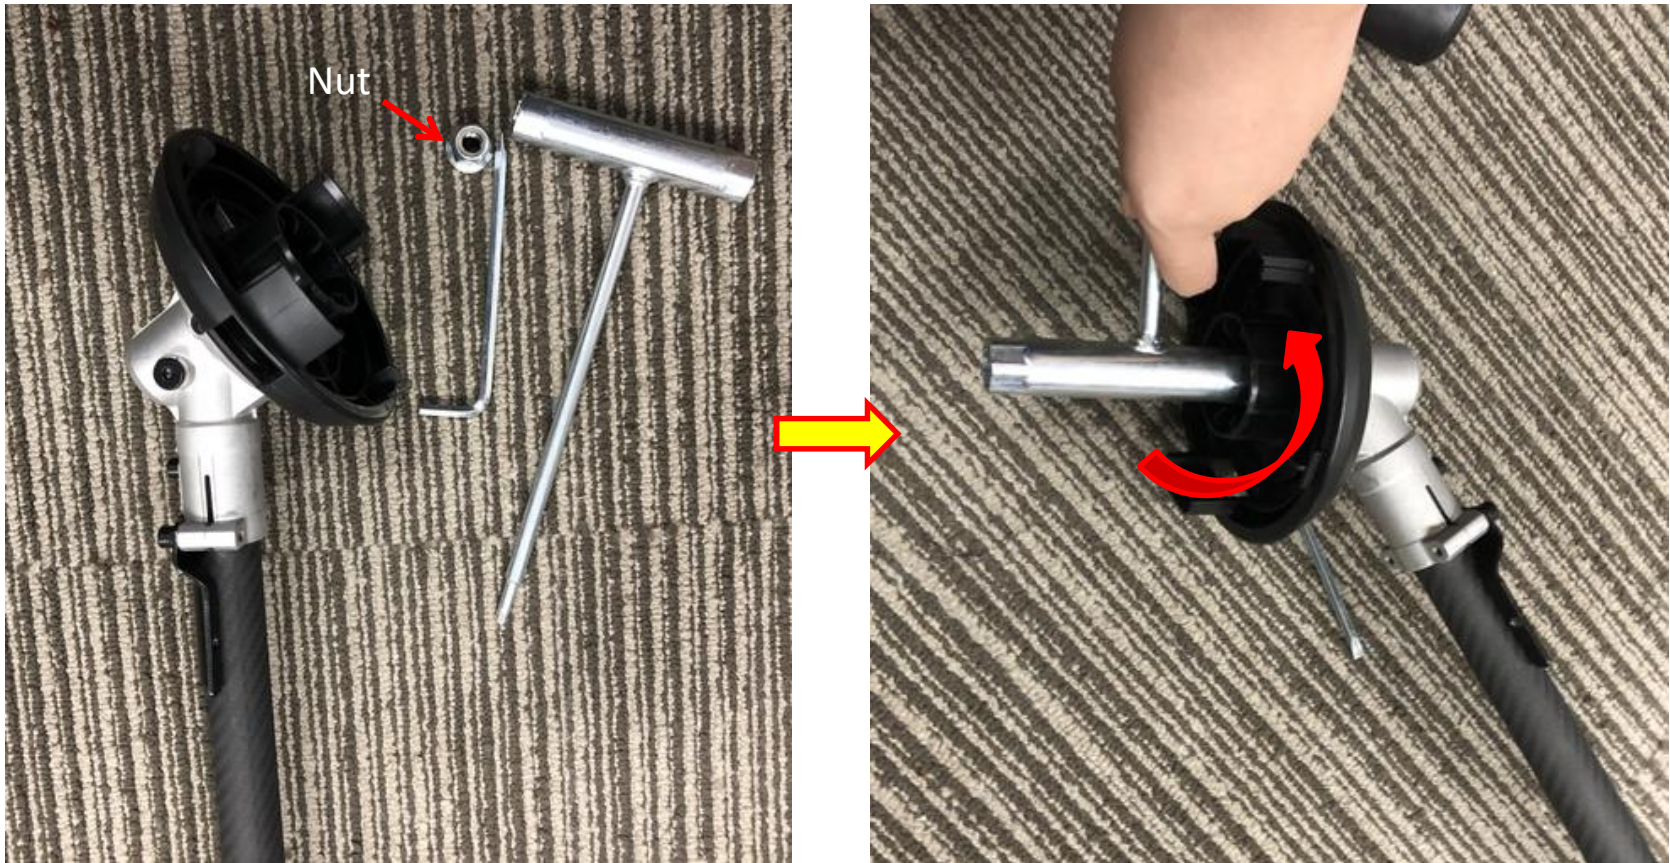
20. Mount the nut onto the shaft and tighten it with multifunction wrench anticlockwise.

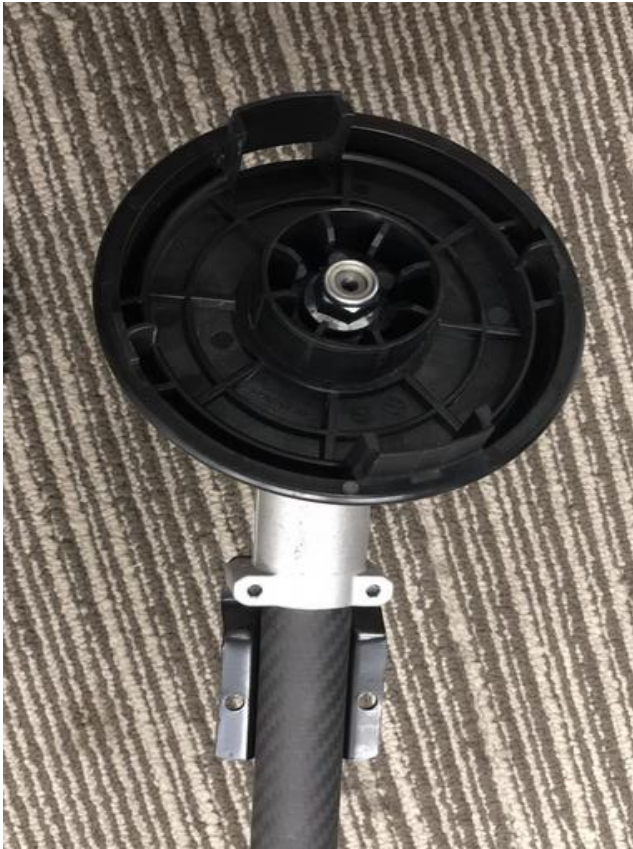
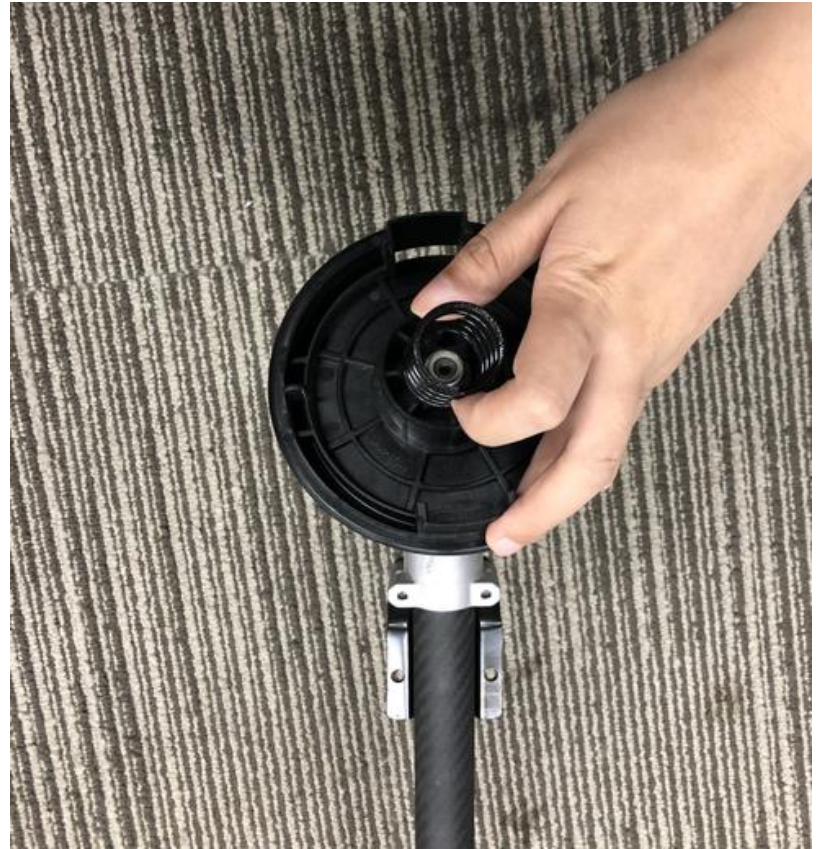
21. Mount the spring onto the upper housing.

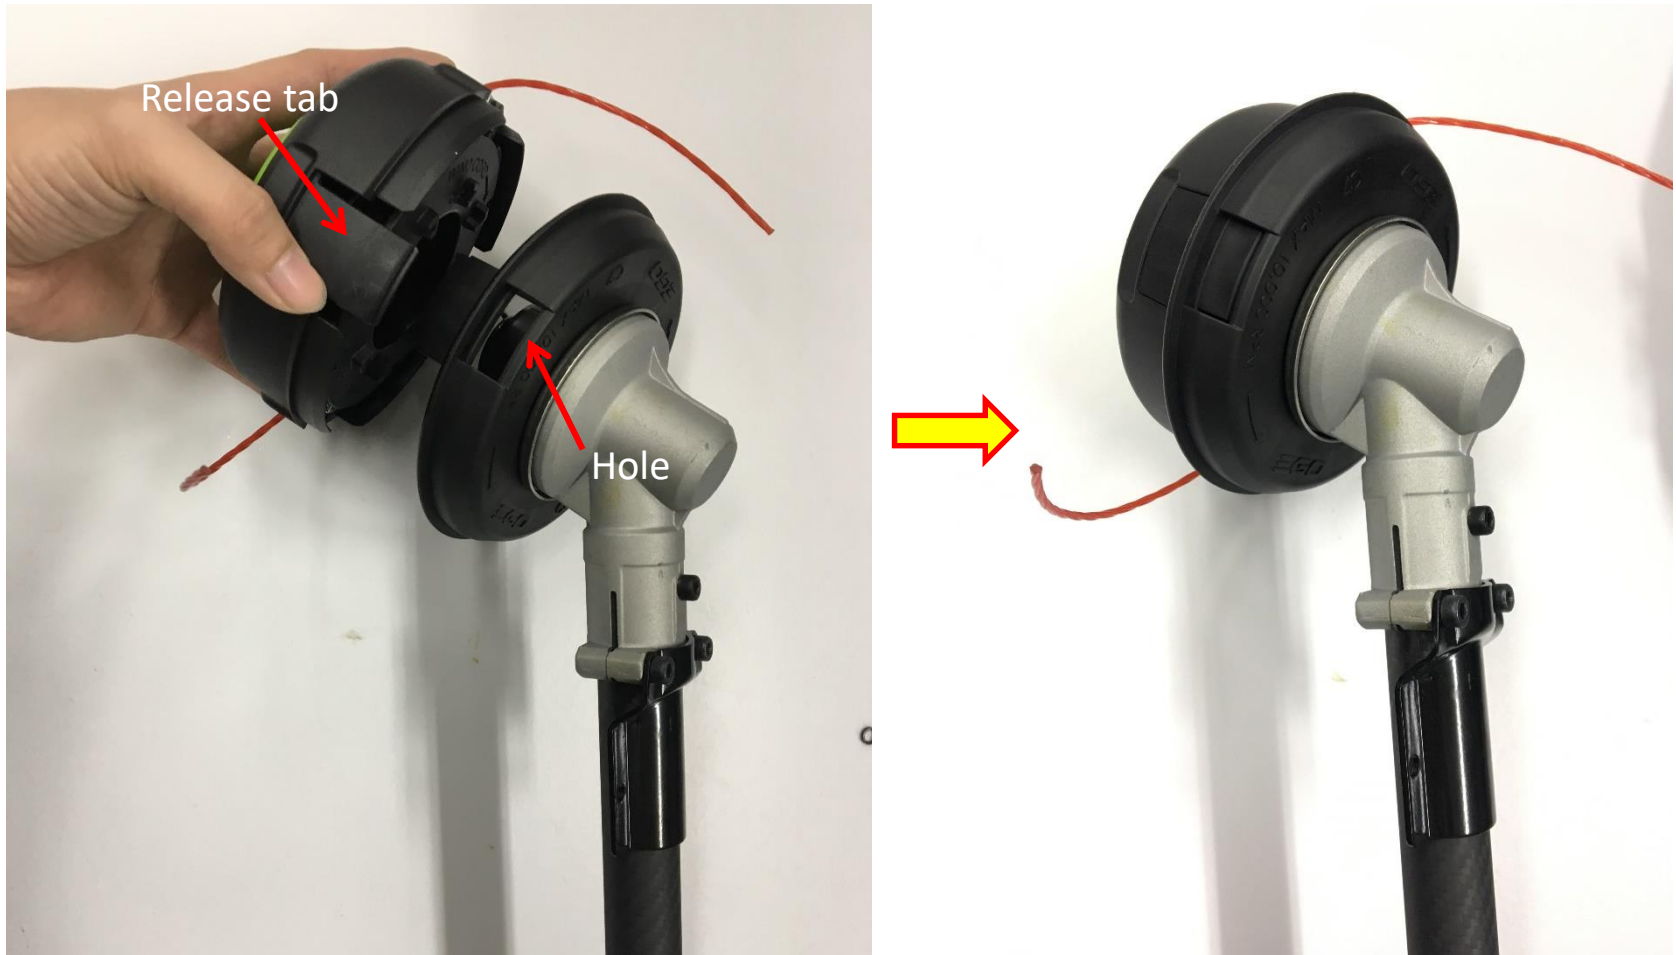
22. Align the release tabs on the lower housing assembly with the holes on the upper housing assembly to assemble them together.

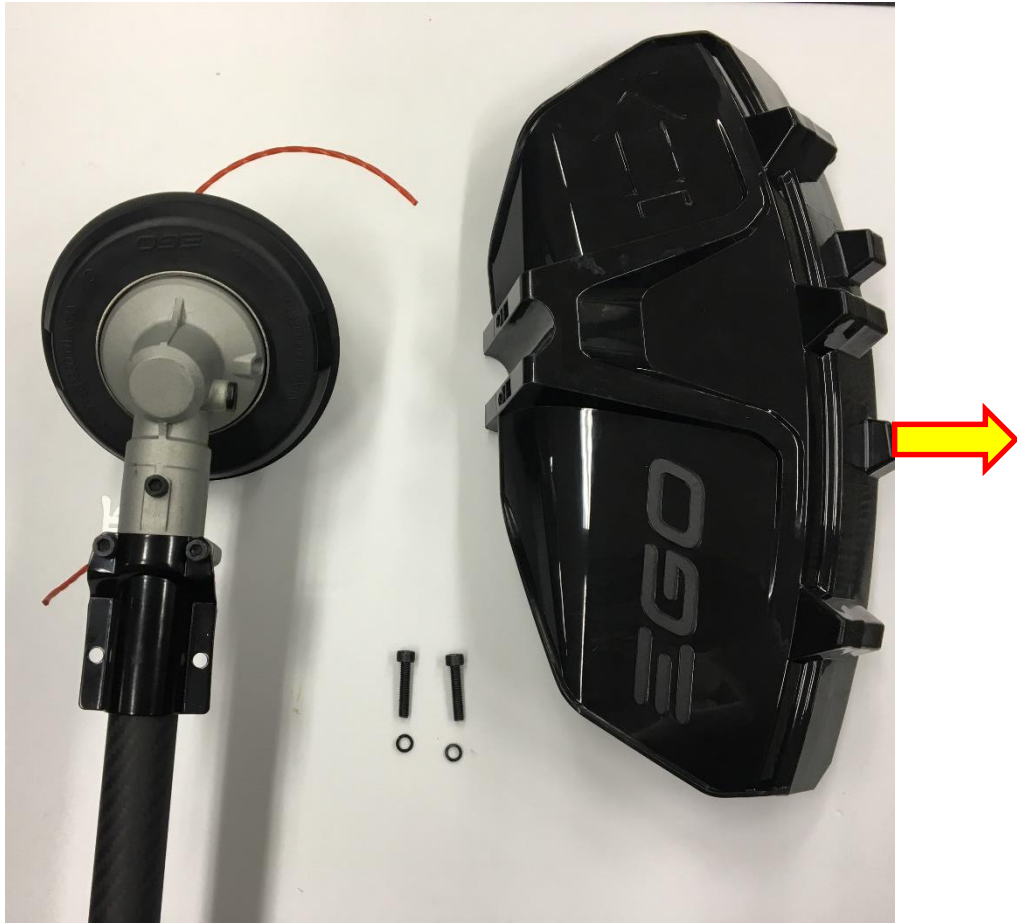
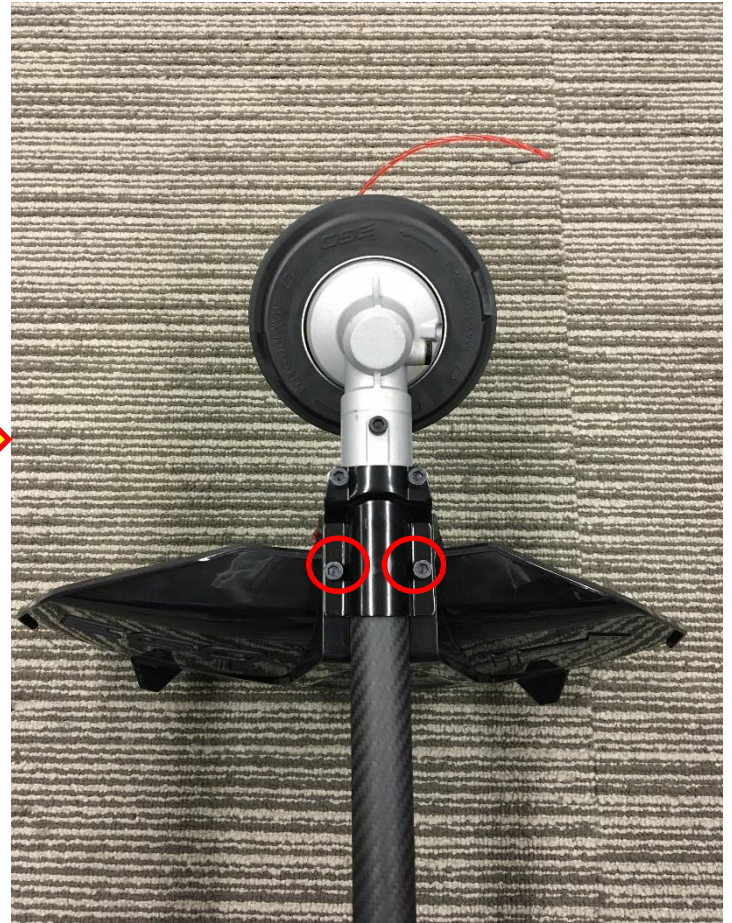
23. Assemble the guard assembly with the fixing board with screws & washer.
