# REPAIR GUIDELINE

Line trimmer \_STX3800

*Version: 1*

*Issue Date: 01/11/2019*

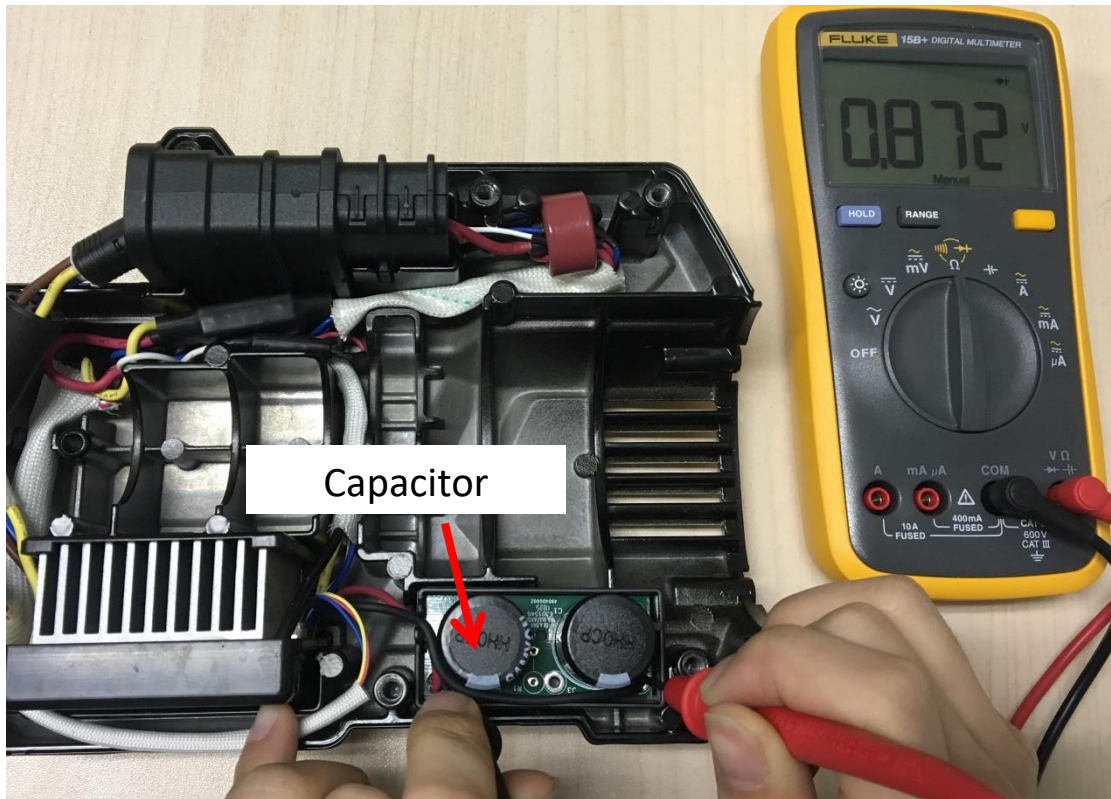
**PCBA Measurement**

1. Following the instructions for “**Replacing the Motor Assembly and PCBA**” to Separate the PCBA.
2. Find the capacitor in the PCBA and set the multimeter function to “Diode measuring”.
3. Contact the red pen pin to the negative electric contact (the joint that connects to black wire).  
Contact the black pen pin to the positive electric contact (red wire).

**Notice:** When the voltage is below 1V and buzzing sound stops, the discharging has finished.

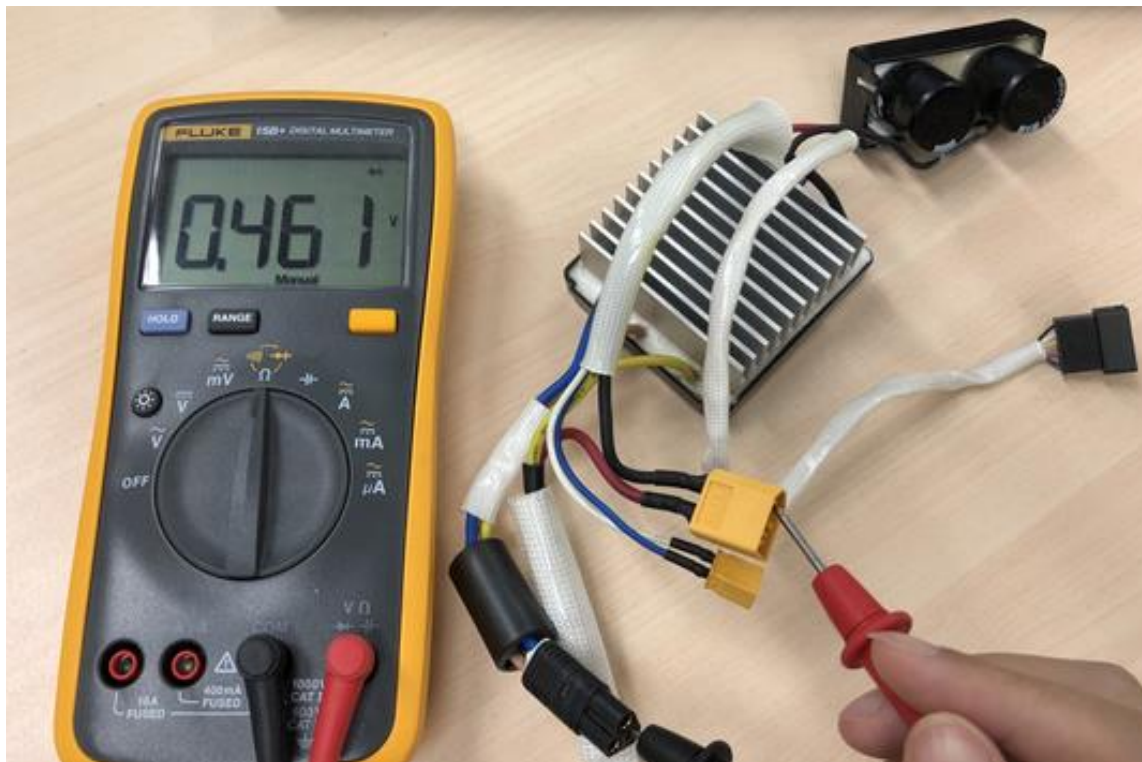
4. Contact the red pen pin to the contact with black wire of the yellow connector (connect to the internal wire assembly) and the black pen pin to the three contactors of the black connector (connect to the motor).

**Notice :** If the LCD displays 0.45~0.55V for each measurement, means a good upper MOSFET, go to the next testing step; otherwise means a broken PCBA, replace a new PCBA.

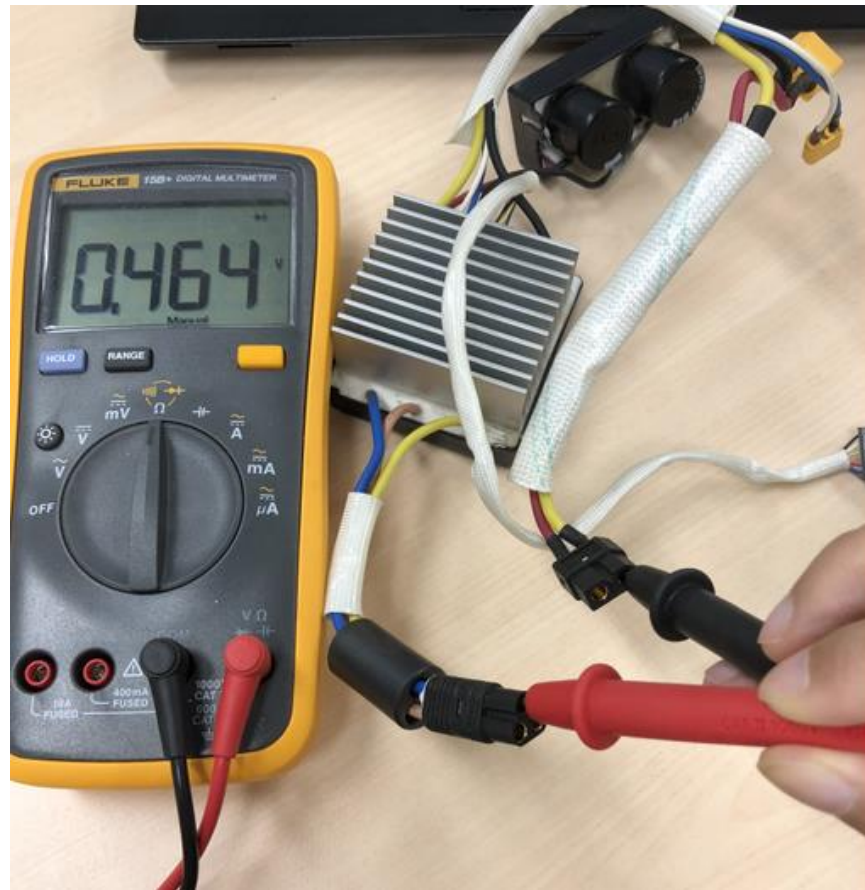
PCBA Measurement

5. Contact the black pen pin to the contact (connect to the yellow line) of the black connector and red pen pin to the three contacts of the black connector (connect to the motor).

**Notice :** If the LCD displays 0.45~0.55V for each measurement, means a good upper MOSFET, go to the next testing step; otherwise means a broken PCBA, replace a new PCBA.

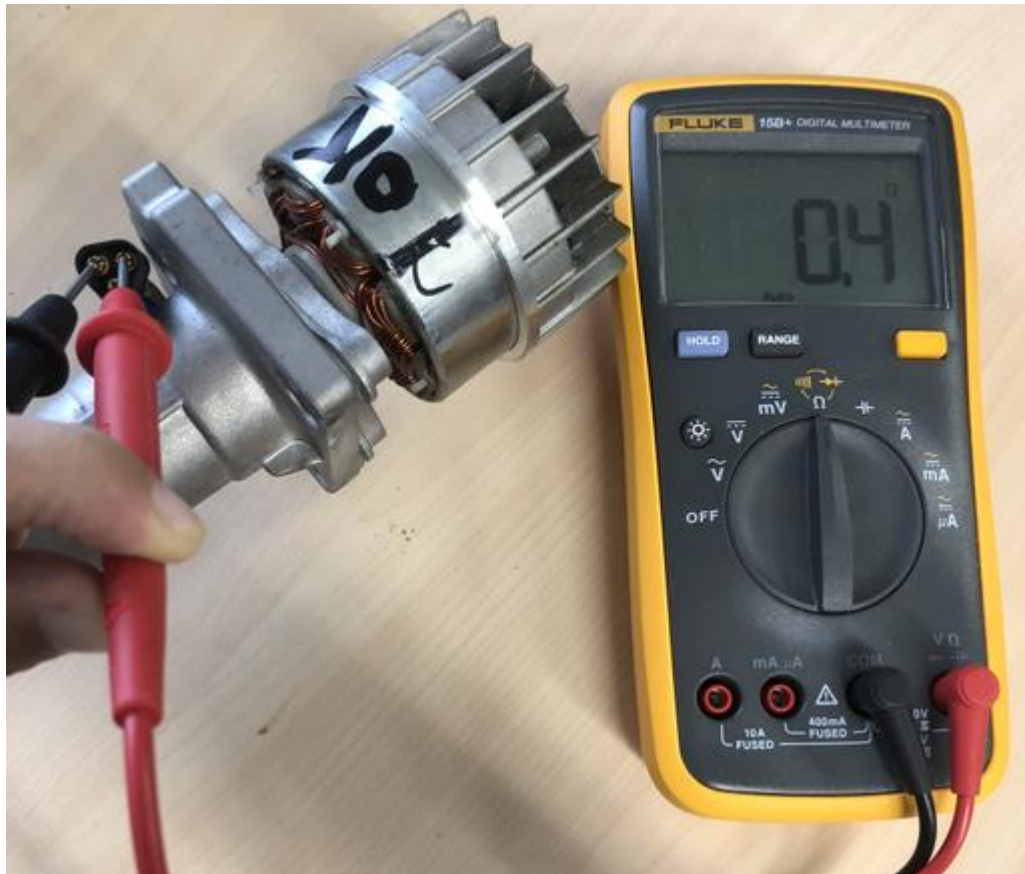
**Motor Measurement**

1. Following the instructions for “**Replacing the Motor Assembly and PCBA**” to Separate the PCBA.
2. Set the multimeter function to “Resistance measuring”.
3. Measure the resistance between any of the two contacts.

**Notice: If the resistance is not infinite, means a good motor. Otherwise, replace the damaged motor**

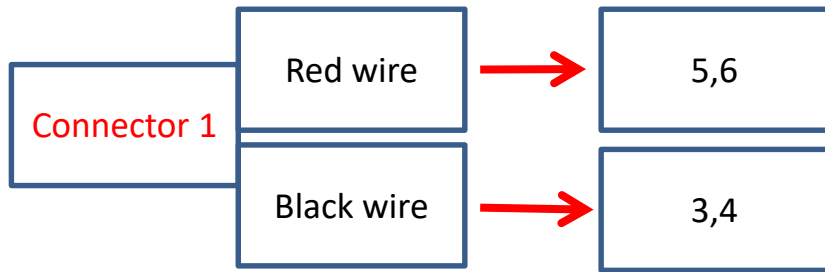
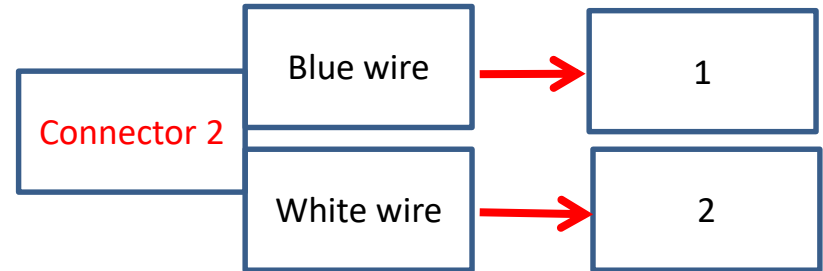
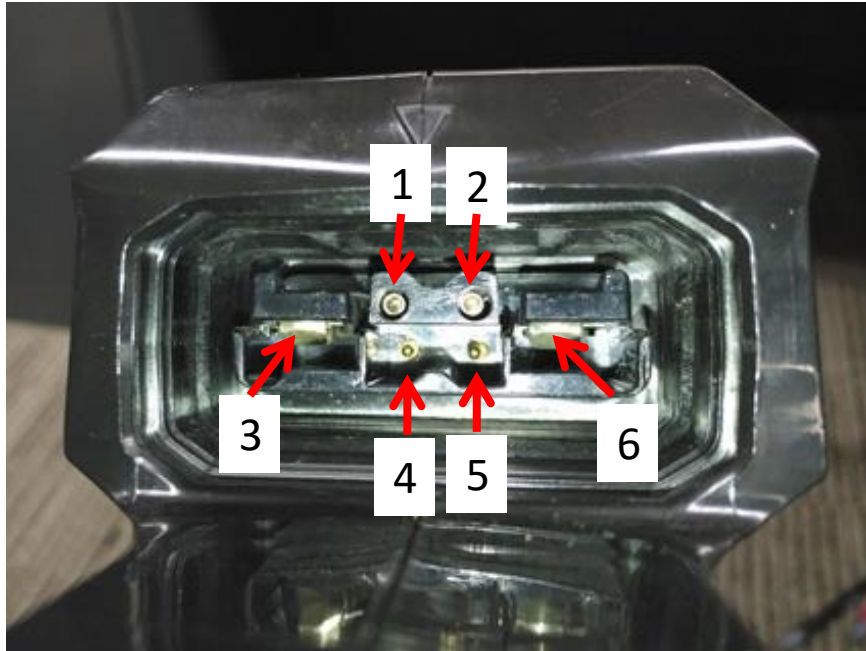
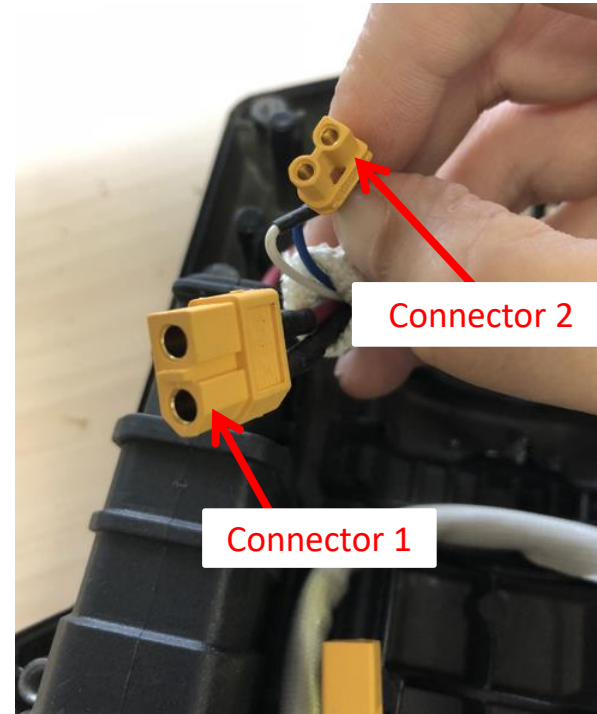
**Internal Wire Assembly Measurement**

1. There is 6 contacts in the socket. Contact the black pen pin to the 6 contacts and the red pen pin to their corresponding contacts of the two connectors.

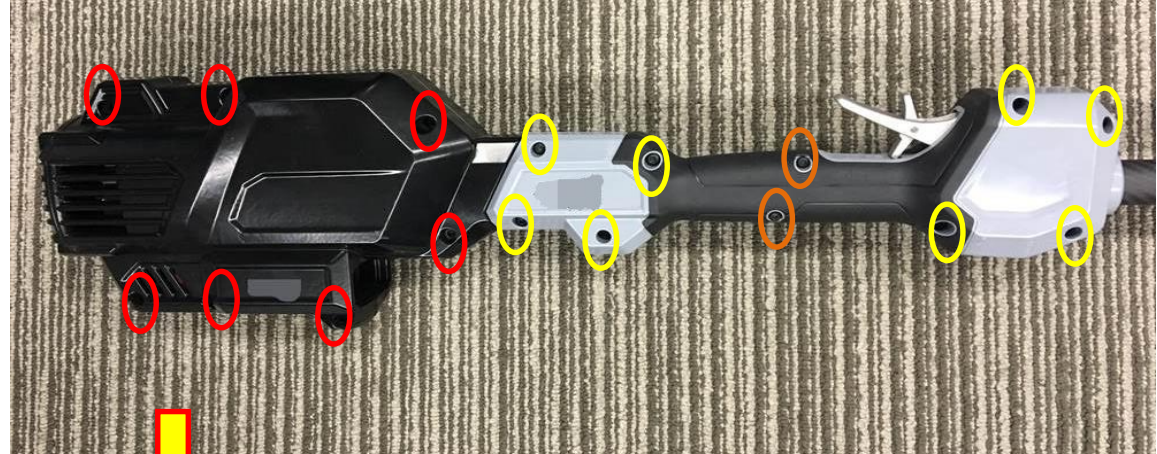
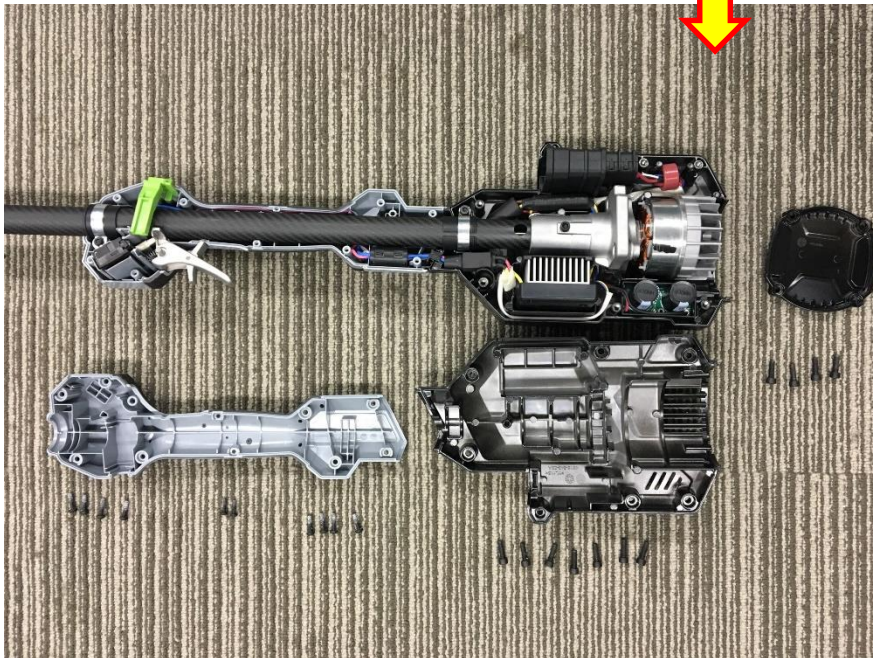
1. Loosen Hexagon socket screws & 8 screws & 2 tapping screws to disassemble the housing assembly.

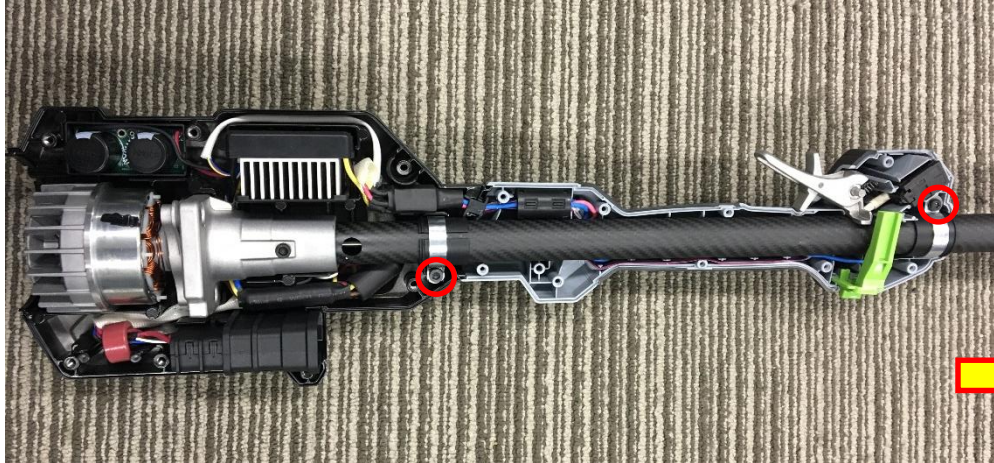
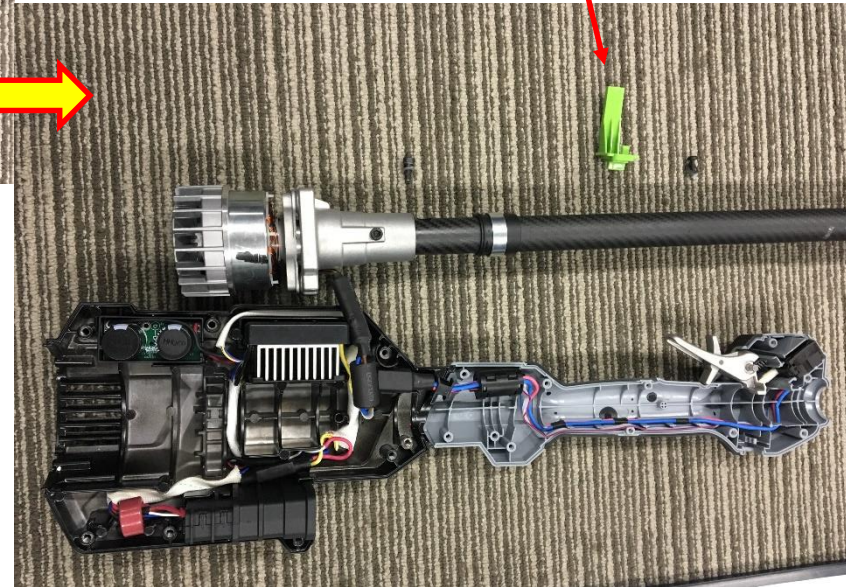
Push button

2. Loosen the screw on the fixed ring.
3. Take push button, the shaft and motor out its groove.

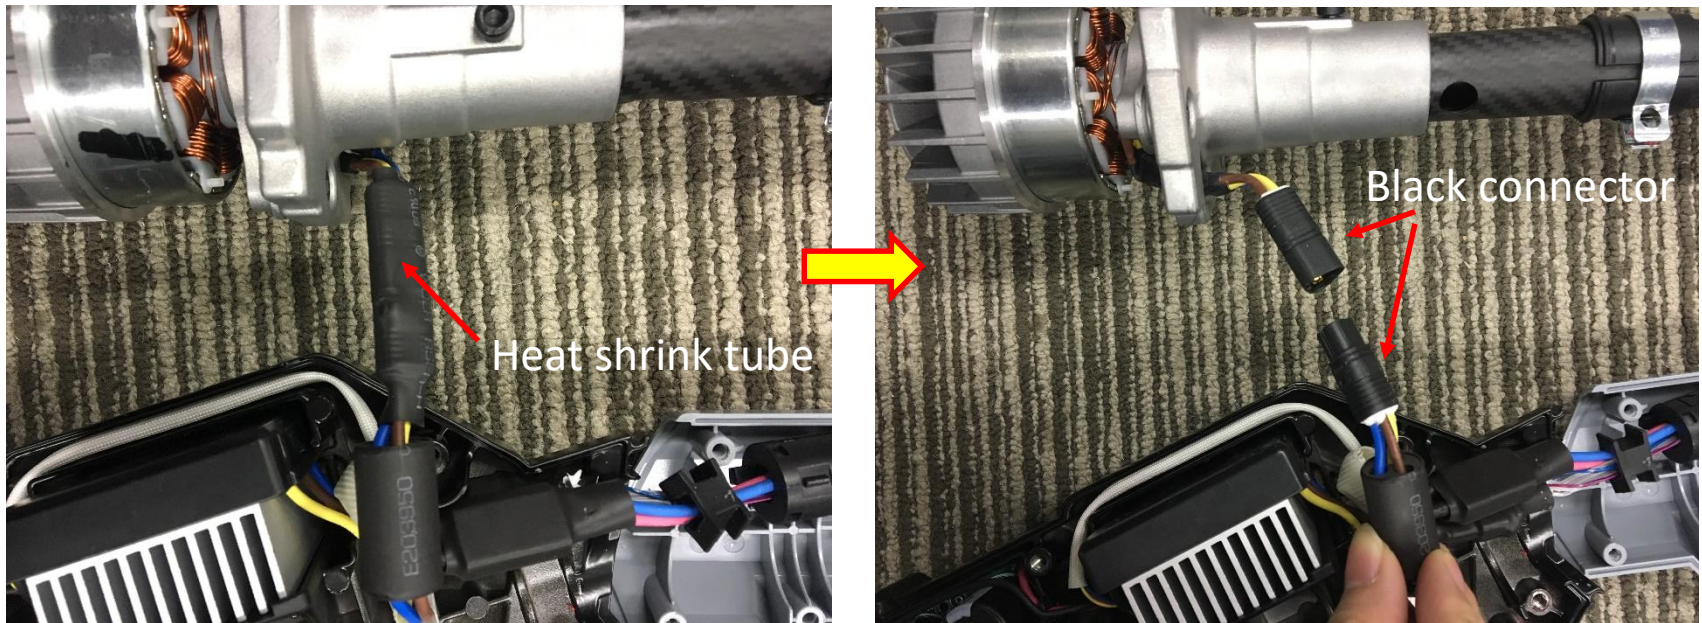
4. Remove the heat shrink tube and disconnect the black connector to detach the motor and PCBA.

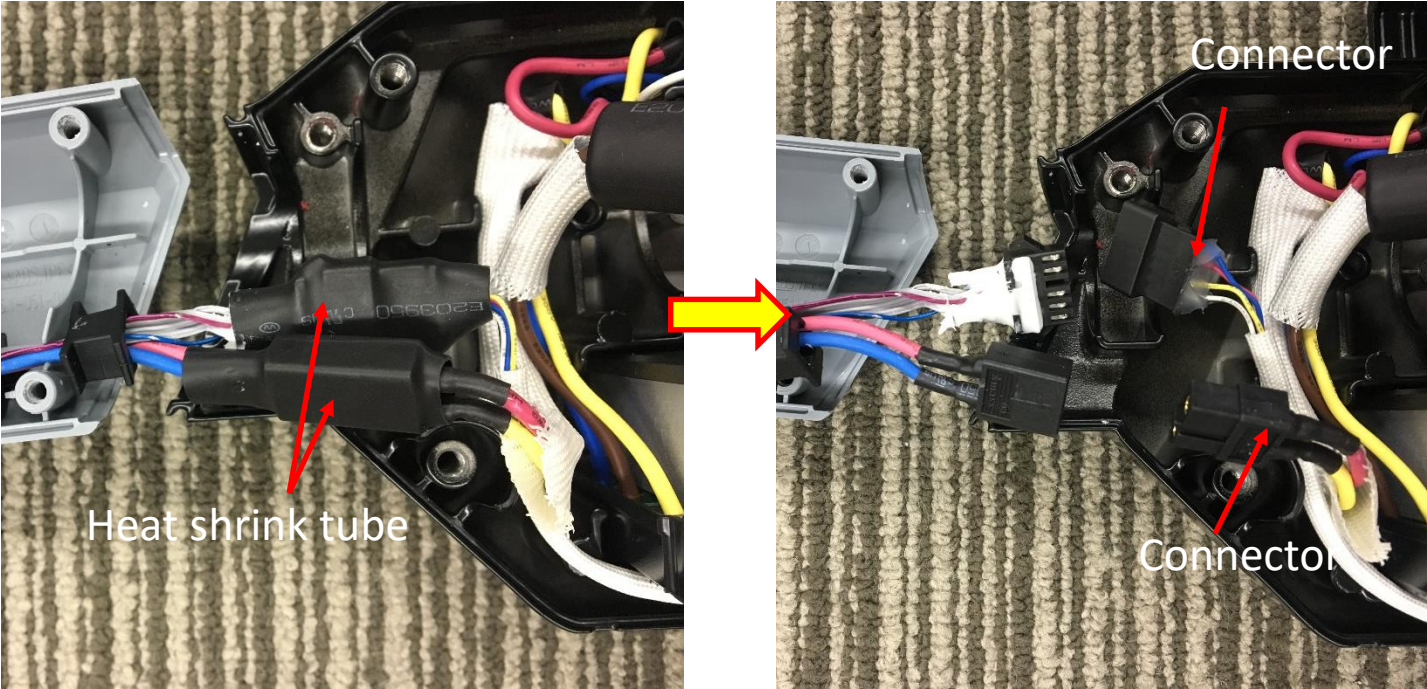
5. Remove the two heat shrink tubes and disconnect the two connectors.

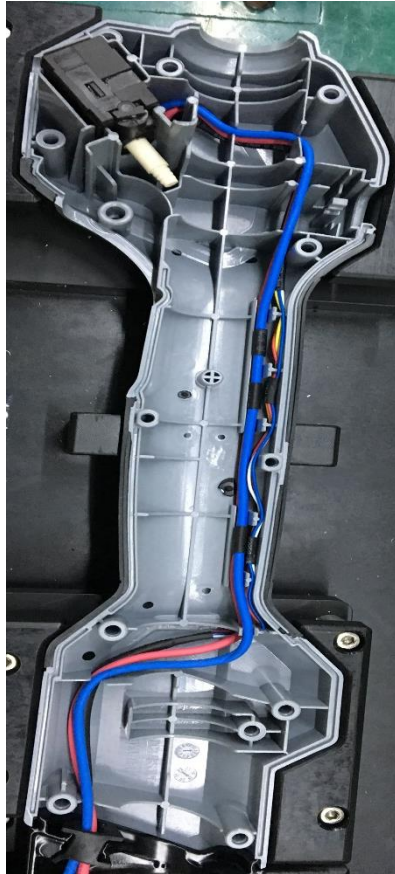
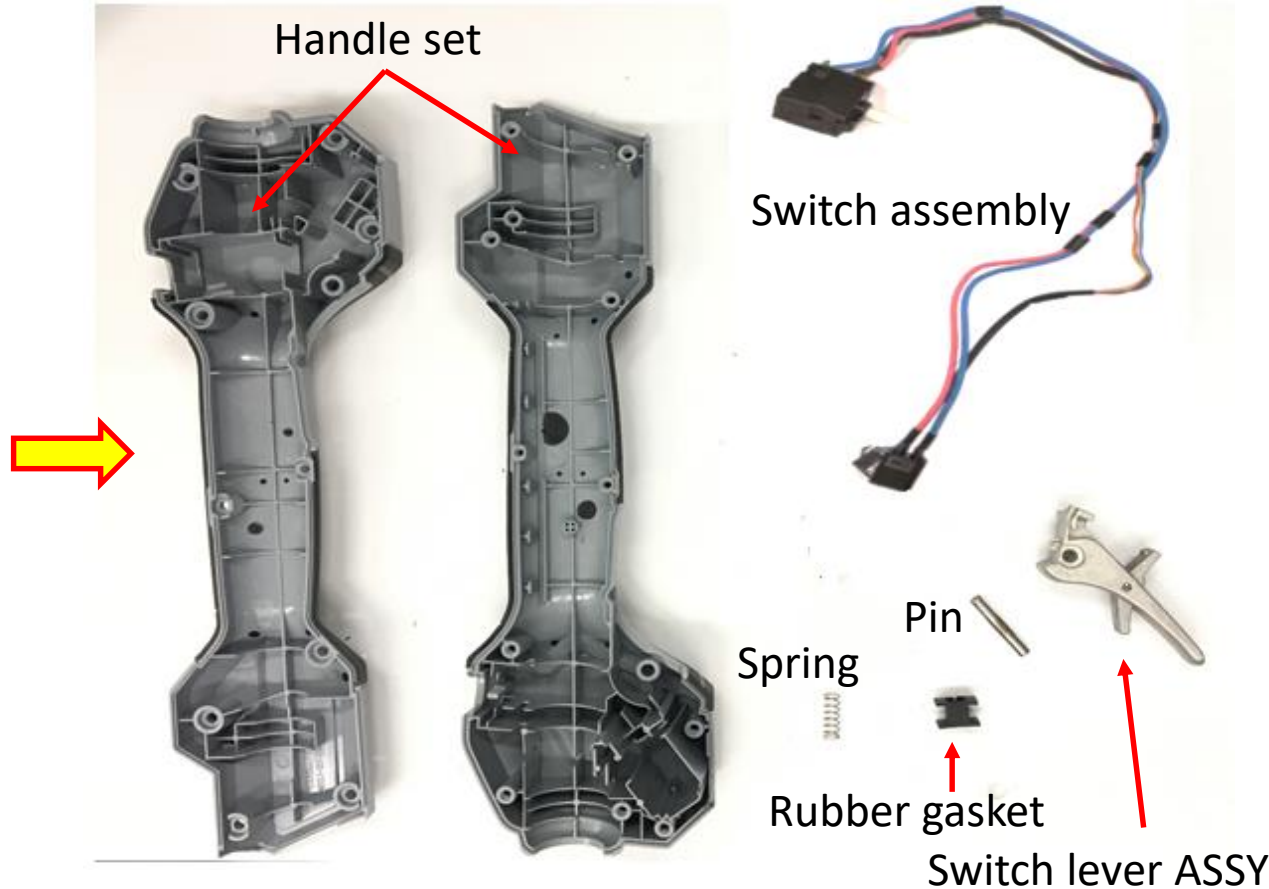
6. Remove all the switches as well as their cables from the handle set, replace the damaged part.

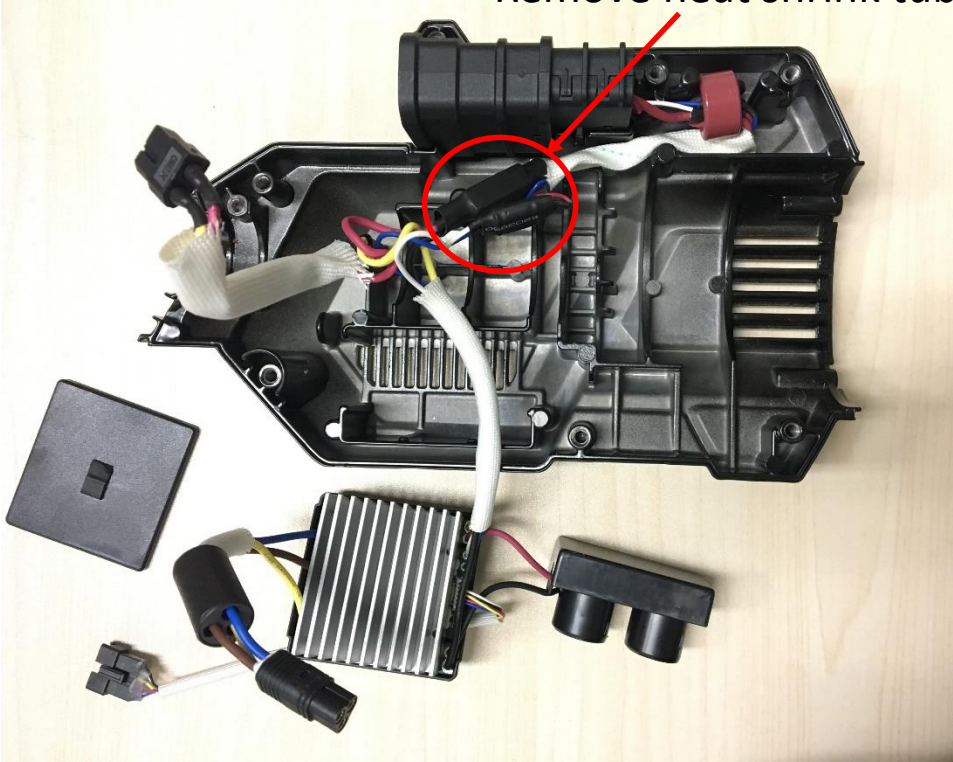
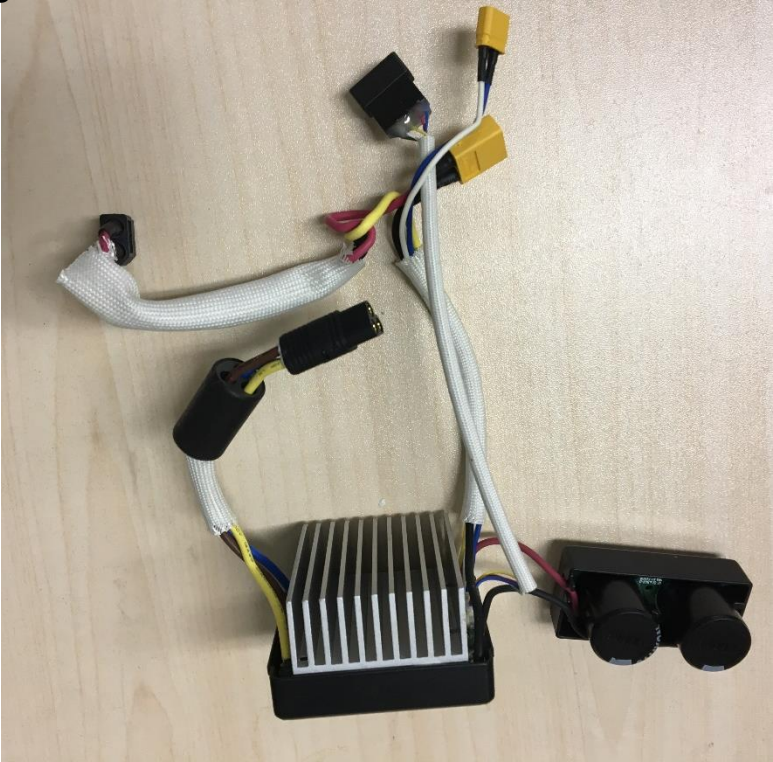
- 7. Take the PCBA away and separate the two connectors from PCBA. If PCBA is damaged, replace it with a new one.

Remove heat shrink tubes

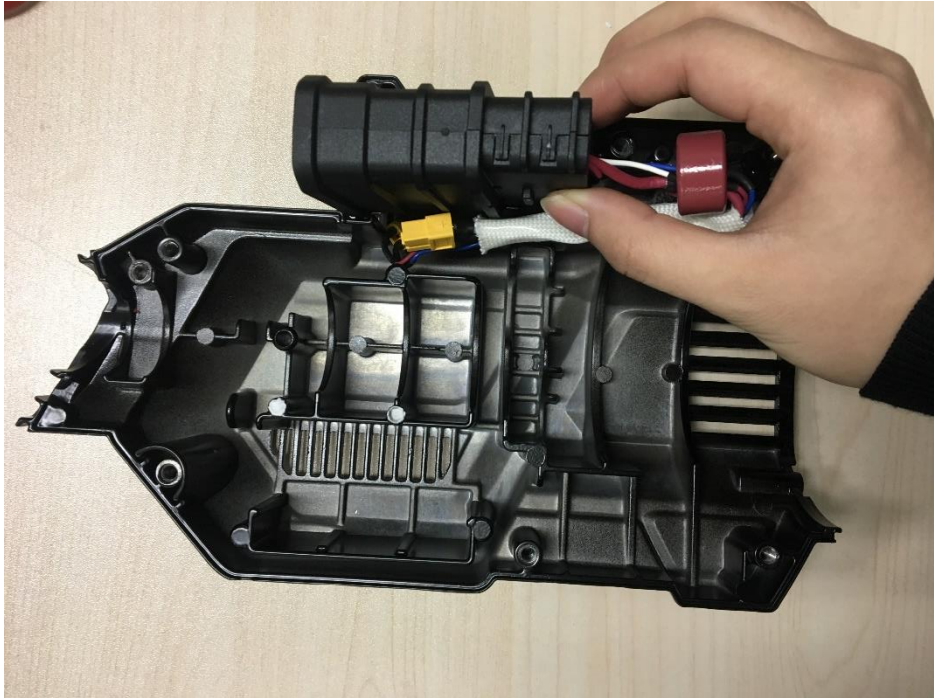
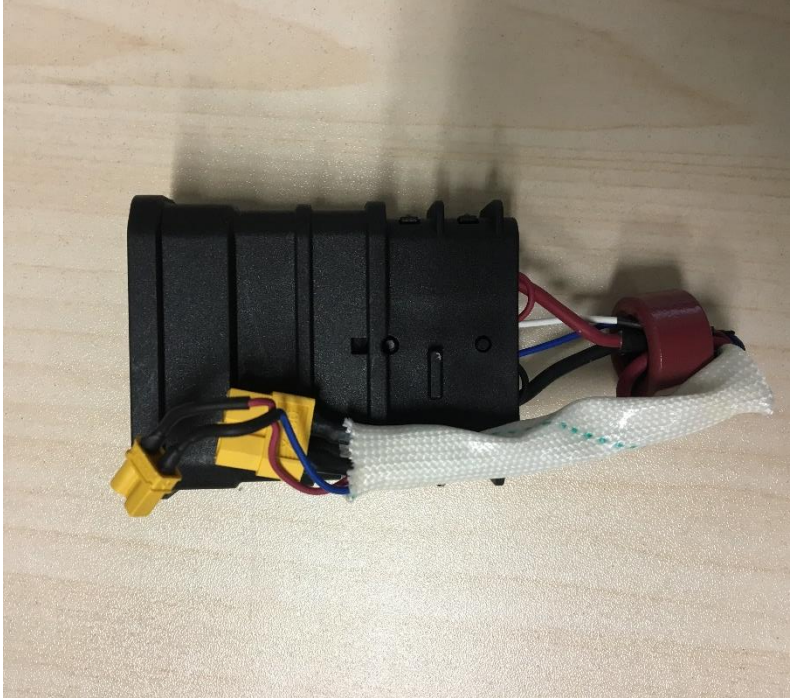
- 8. Take the internal wire ASSY away. If the internal wire ASSY is damaged, replace it with a new one.

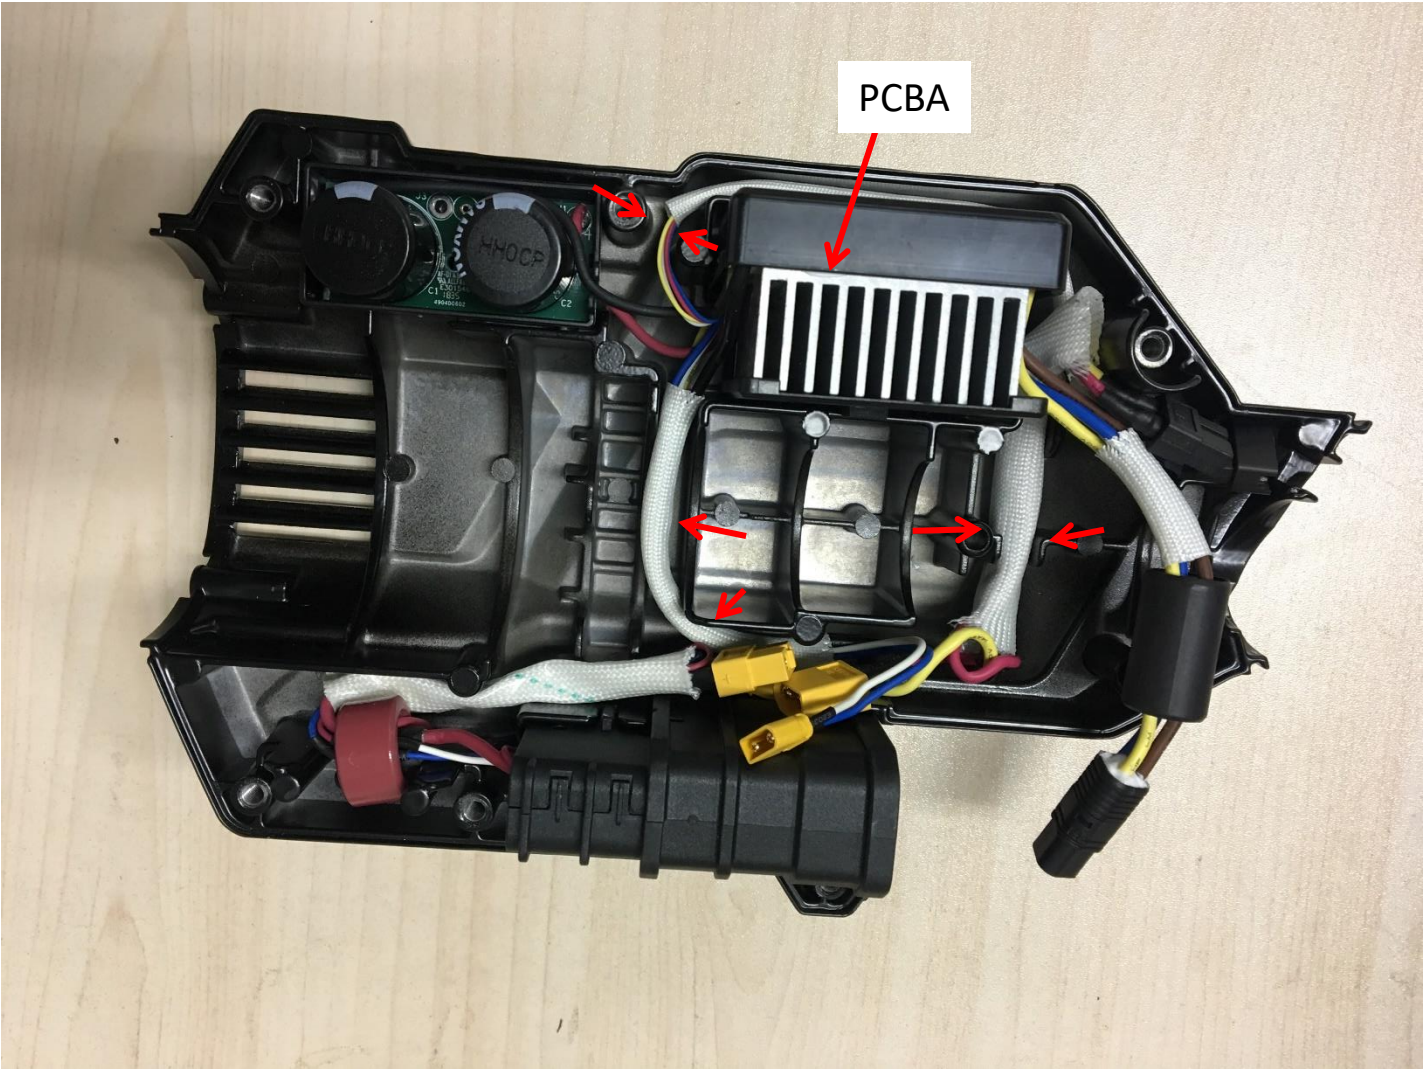
- 9. Align the wires into its groove and mount the PCBA into the housing.

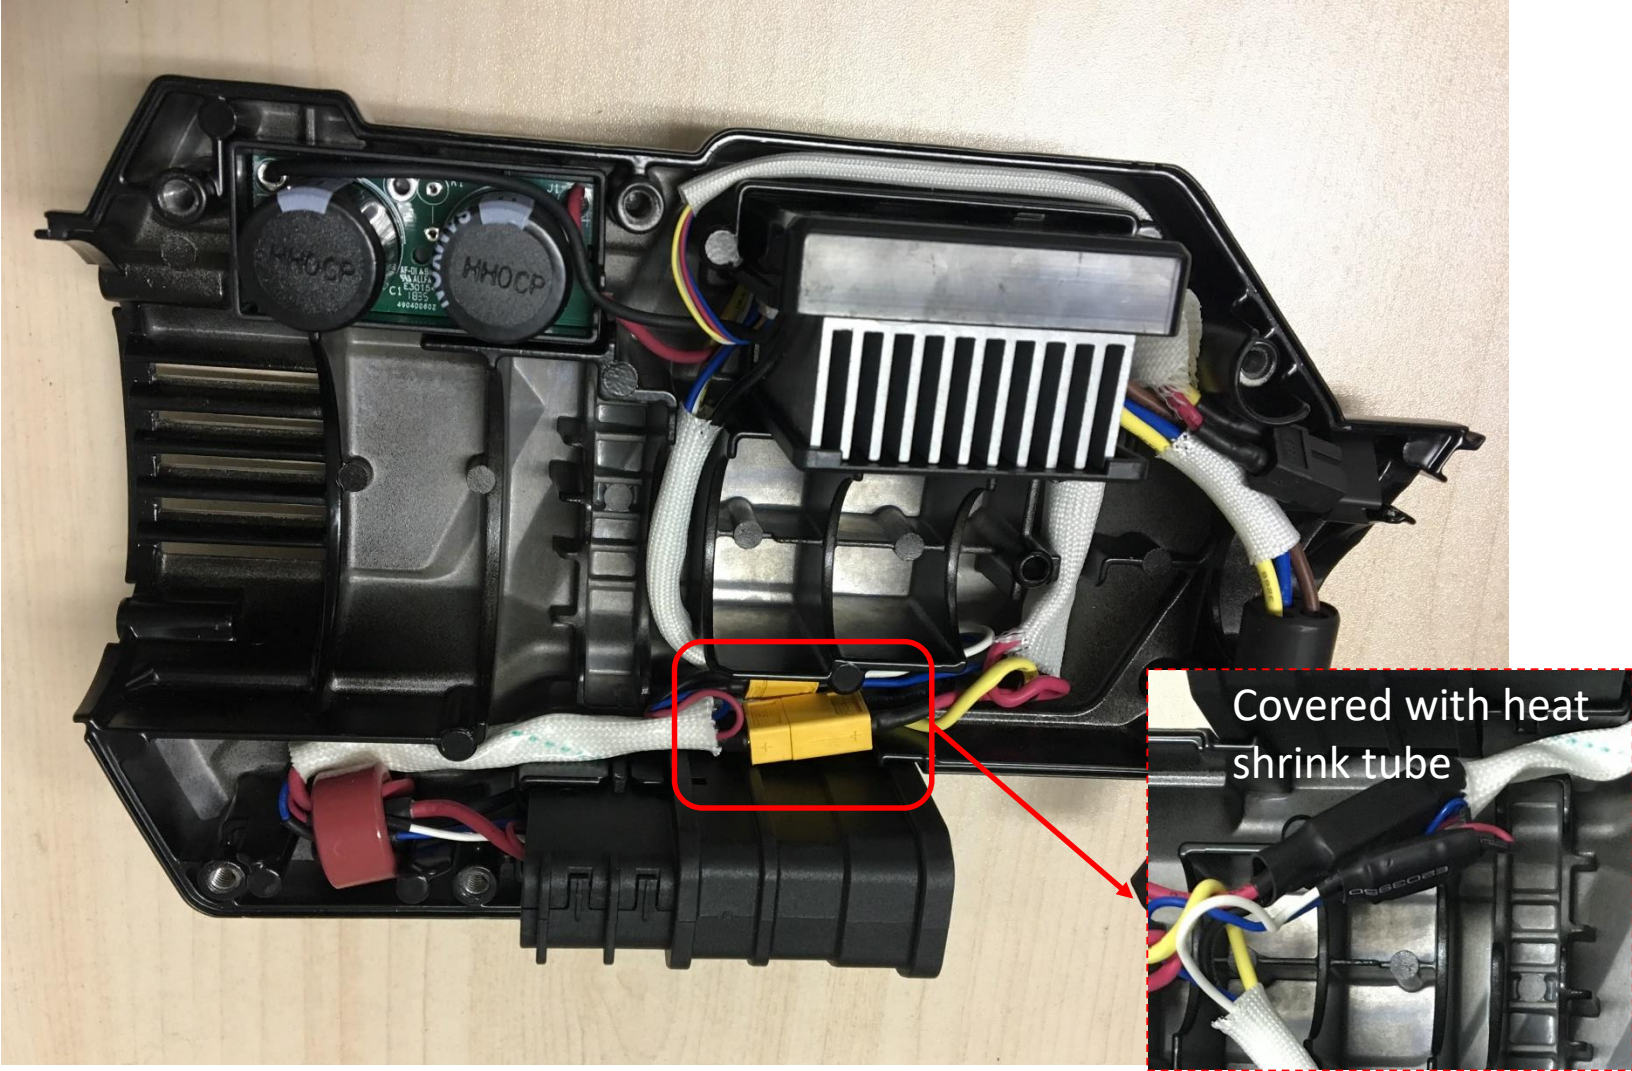
10. Connect the two connectors(yellow in picture) . Then align them into groove.

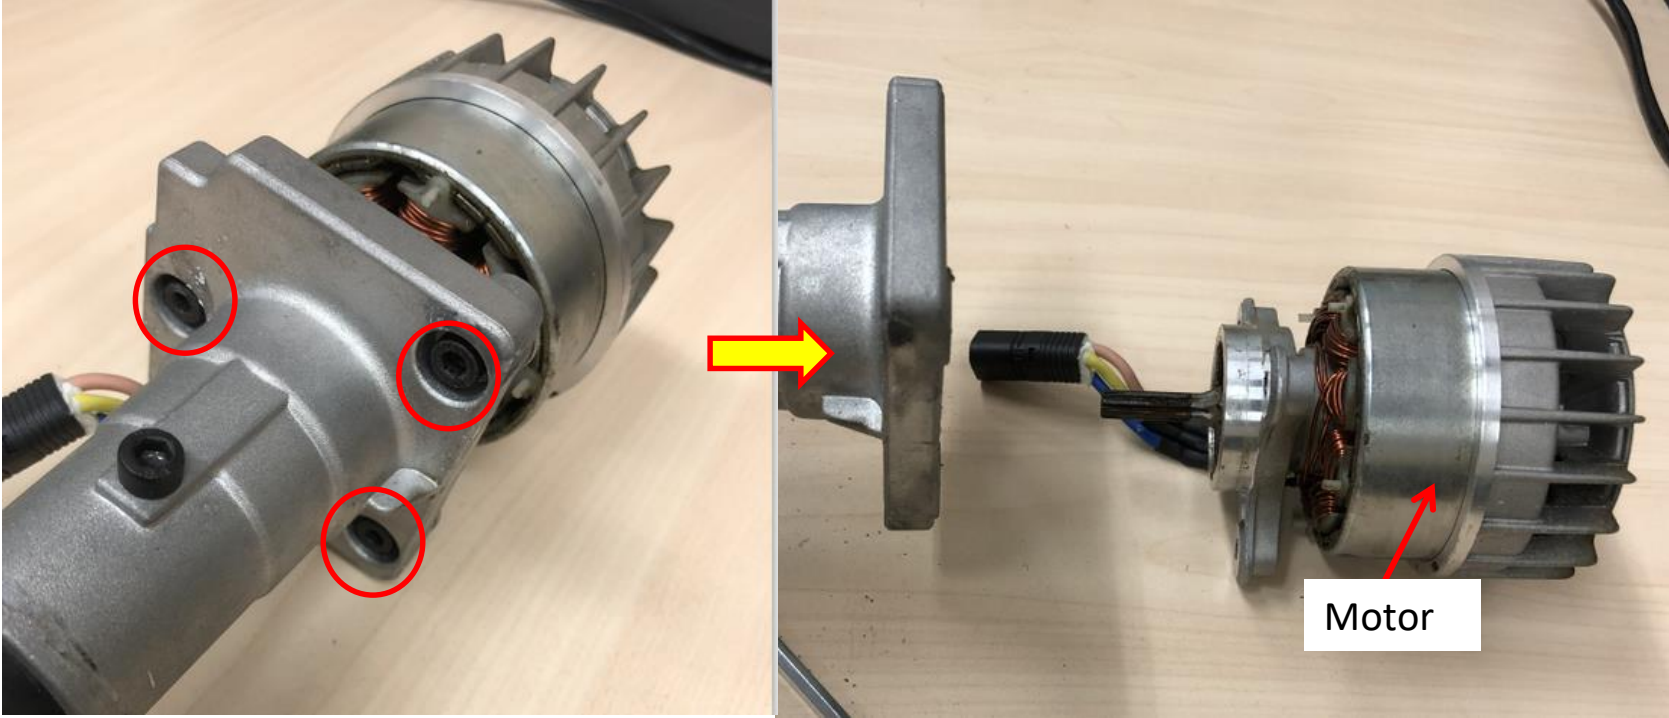
11. Loosen 3 screws to separate the motor from the shaft assembly.

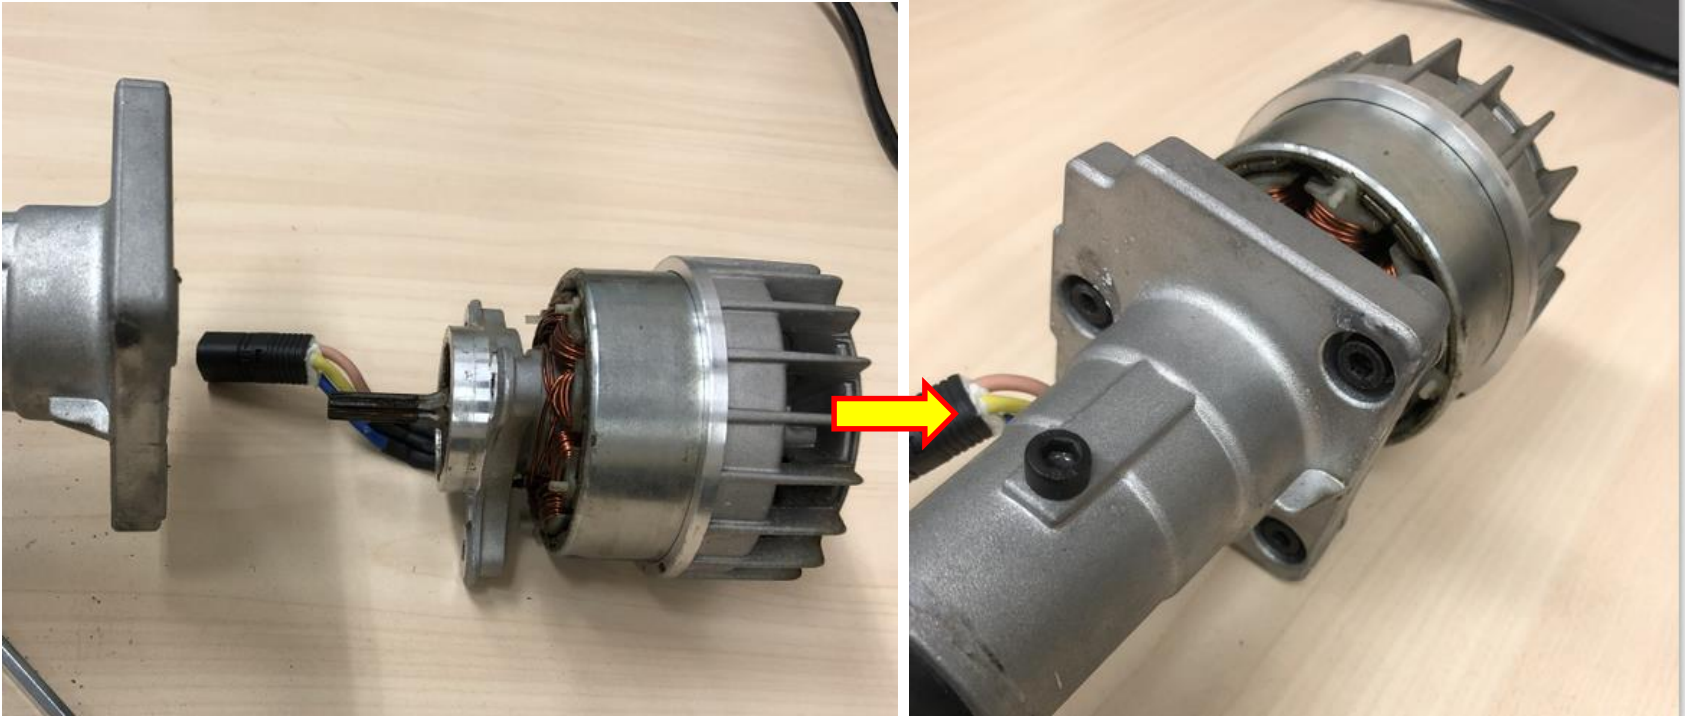
12. Replace the motor with a new one and then assemble the motor with the gear case assembly with screws.

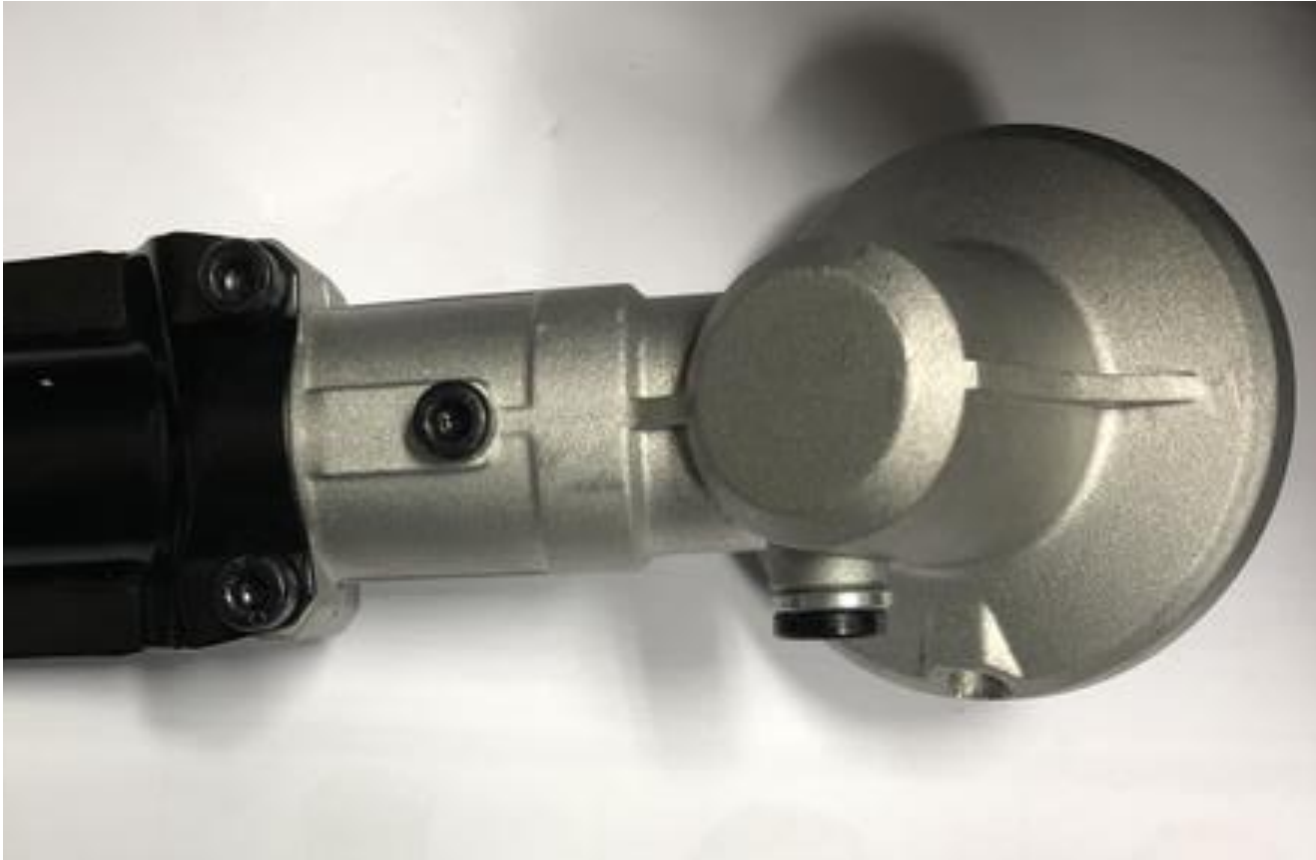
13. Replace the gear case assembly with a new one and assemble the gear case assembly with the shaft assembly with screw.

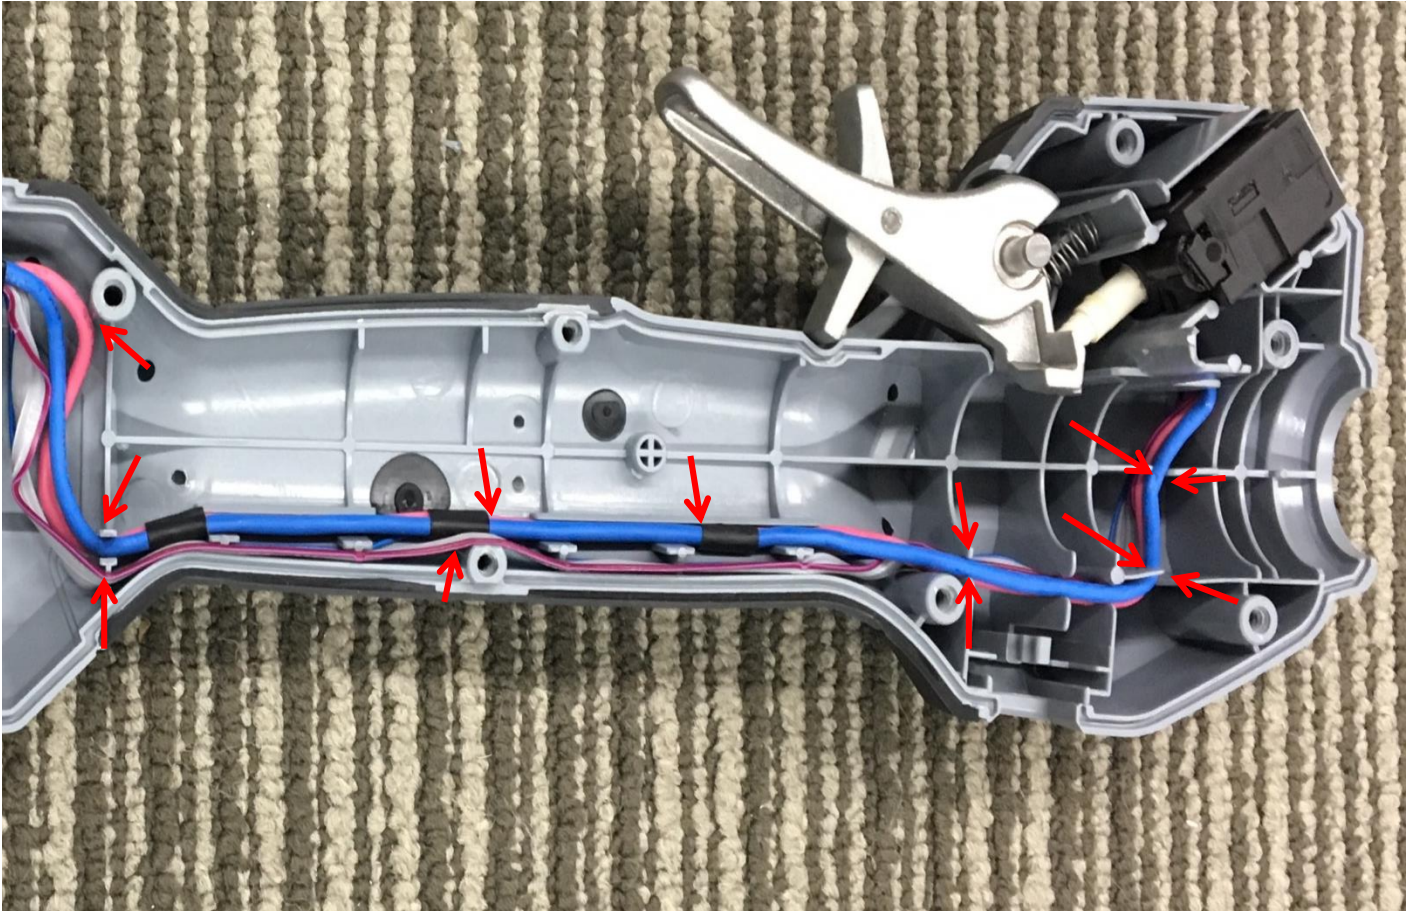
14. Assemble the handle set and align the wires.

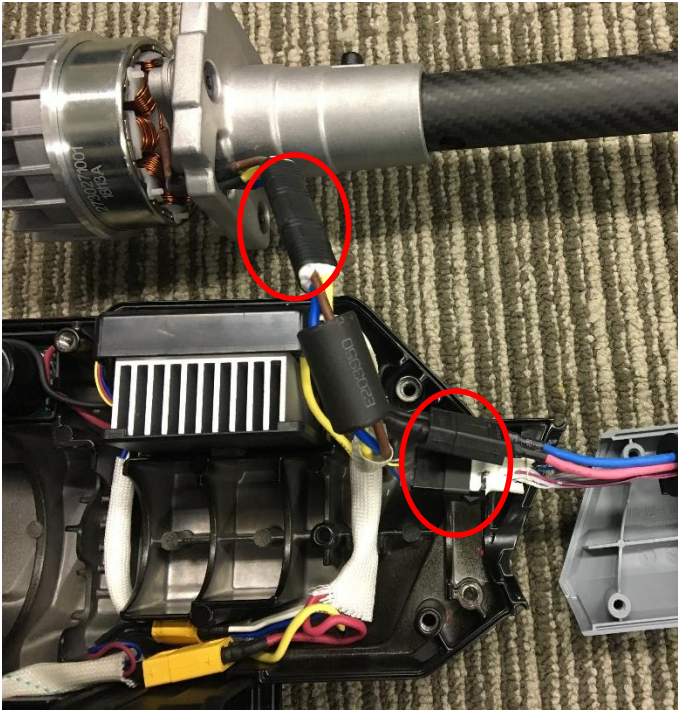
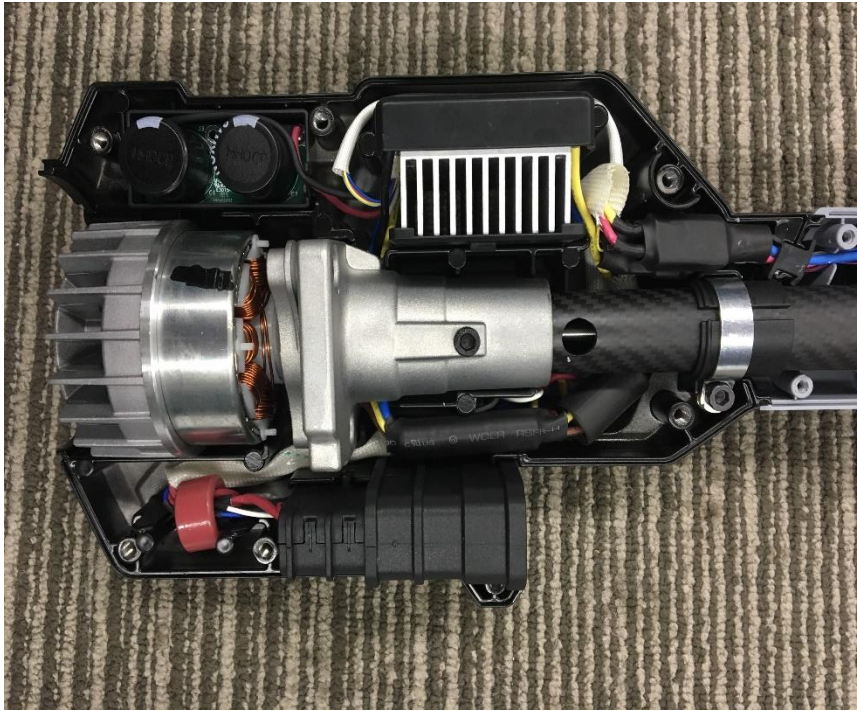
15. Connect the three connector and cover them with heat shrink tube, put the shaft with motor into the housing.
