# REPAIR GUIDELINE

Line trimmer \_STX3800

*Version: 1*

*Issue Date: 01/11/2019*

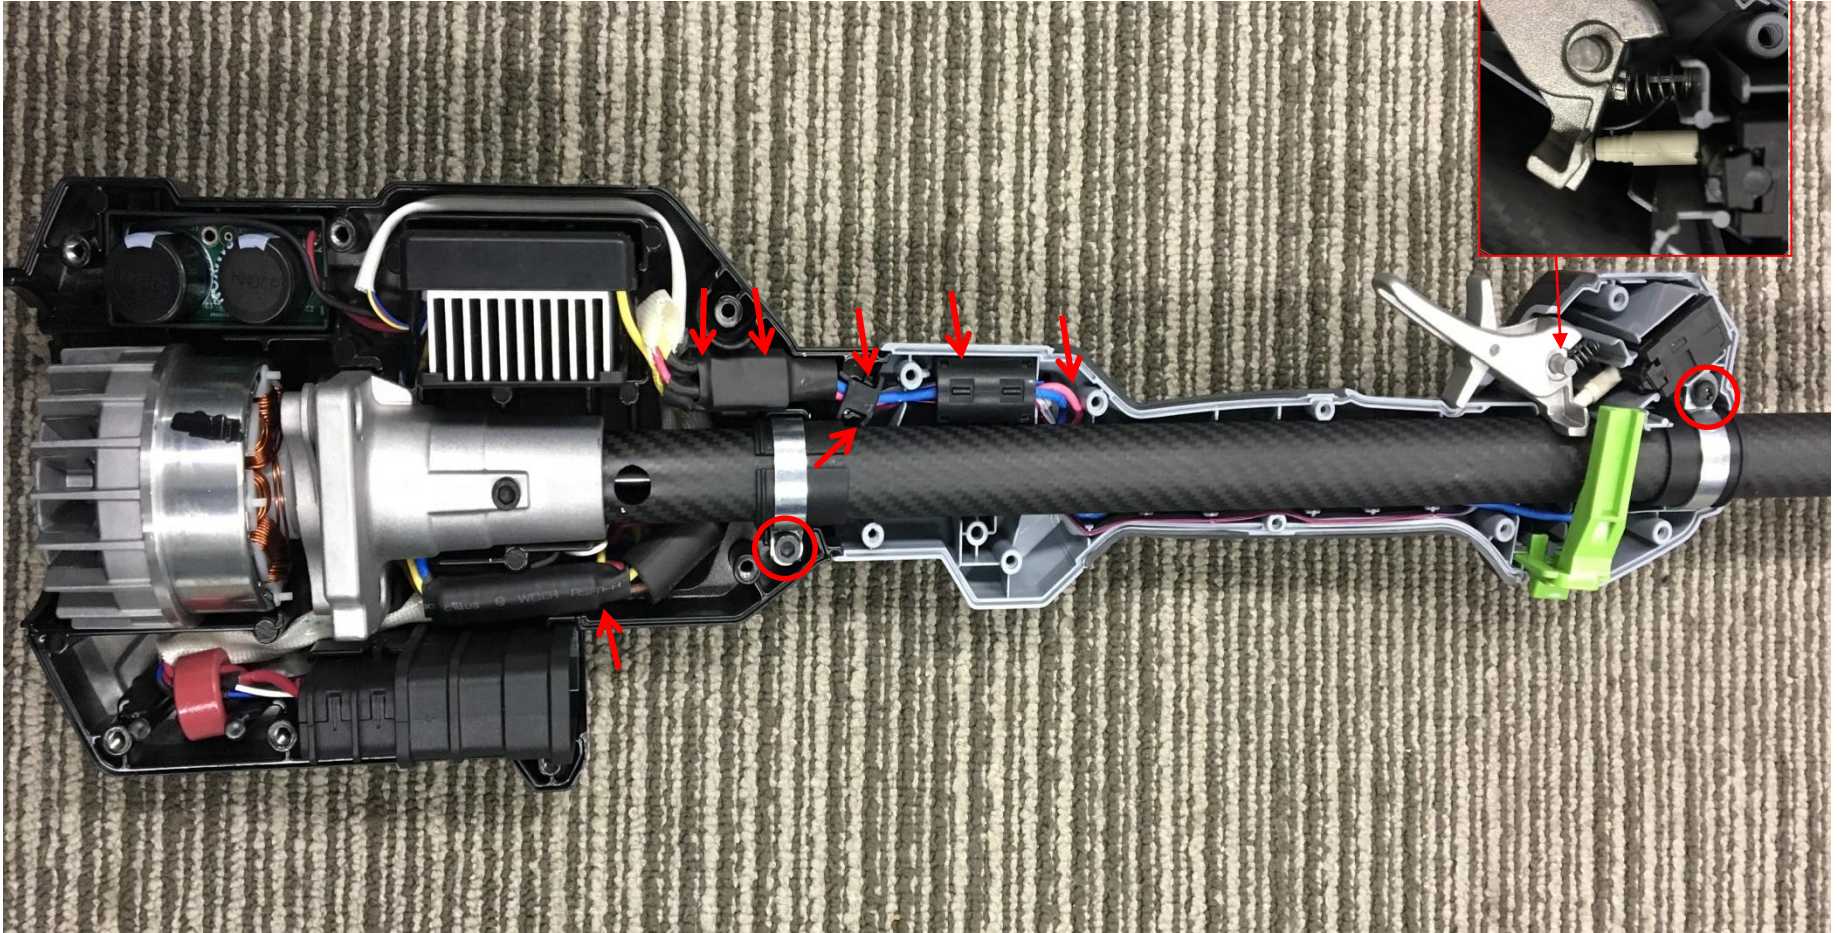
16. Tighten the 2 screws to fix the tube on the housing and handle set, assemble the switch lever assembly and push button on the handle set.

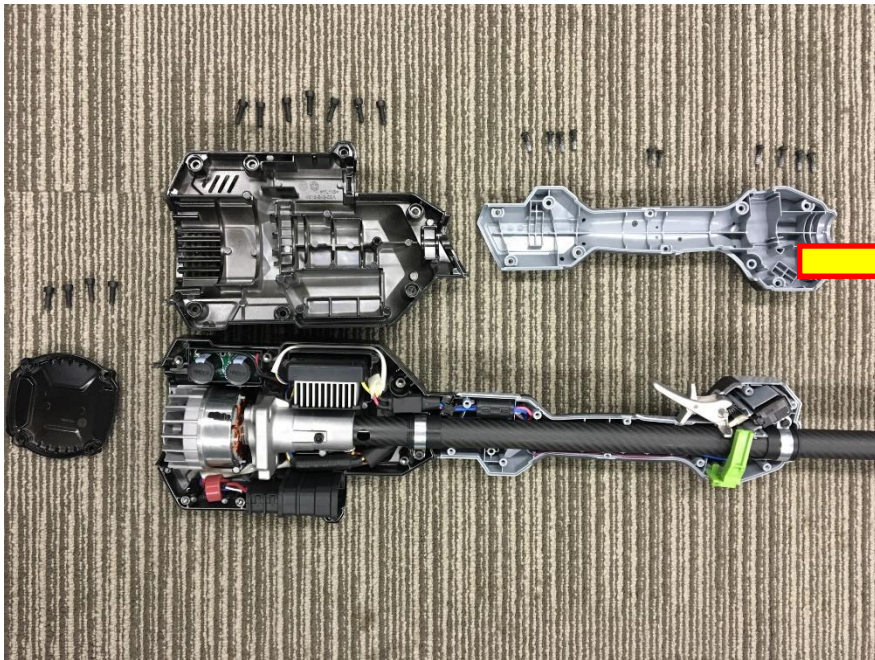
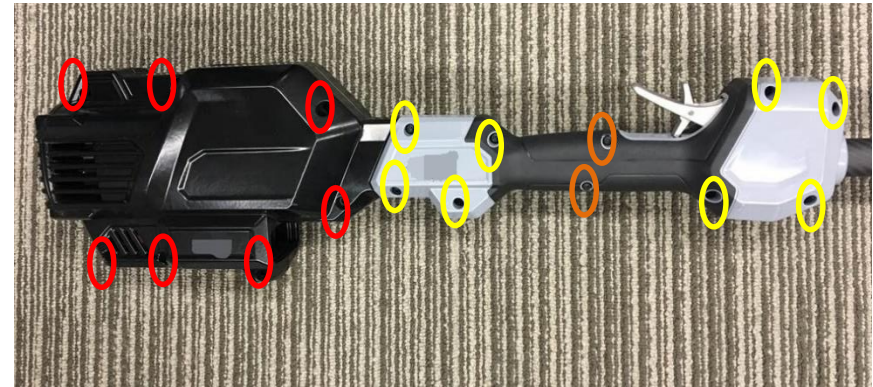
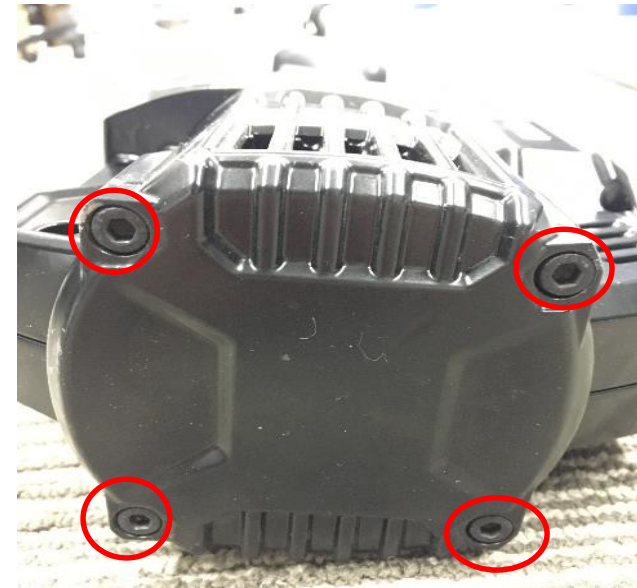
17. Assemble the housing assembly with 17 screws. Then assemble the Rear Cover with 4 screws.

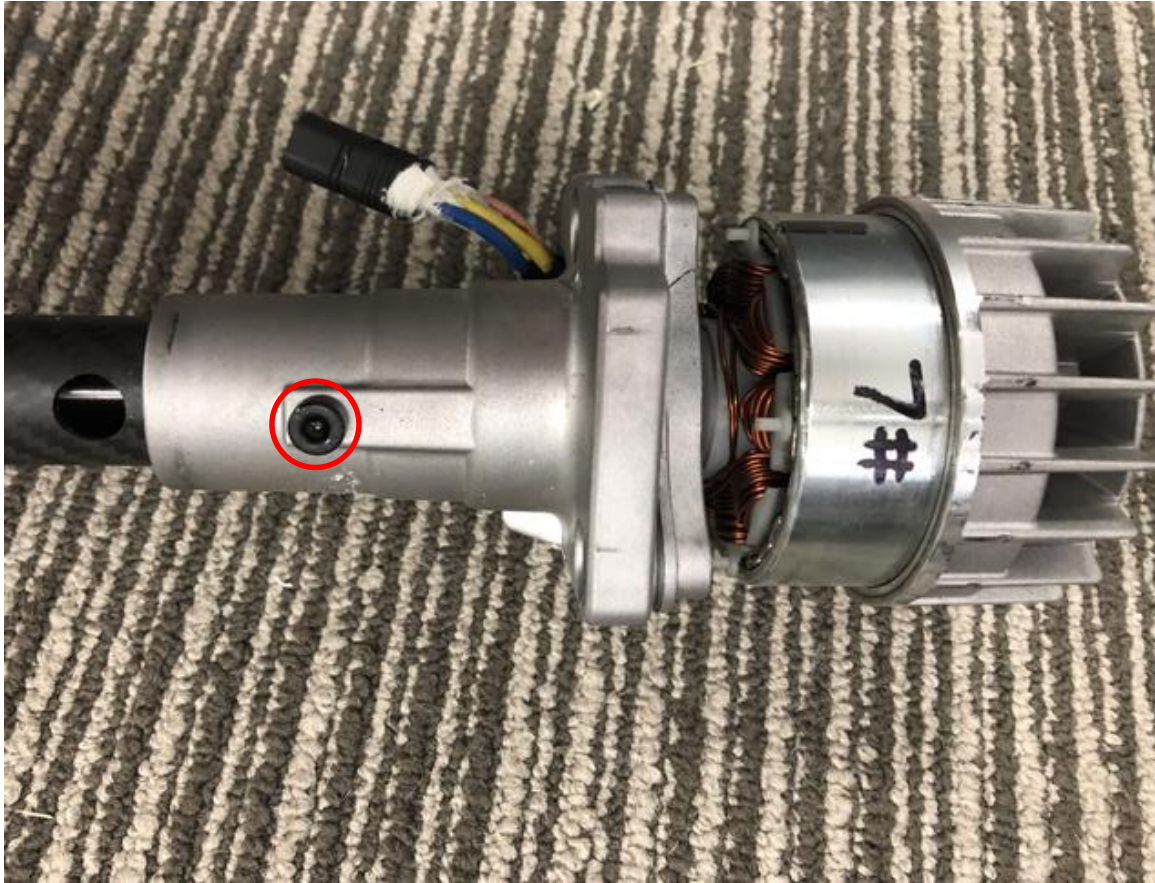
- 1. Loosen the screw to separate the motor & base assembly from the shaft.

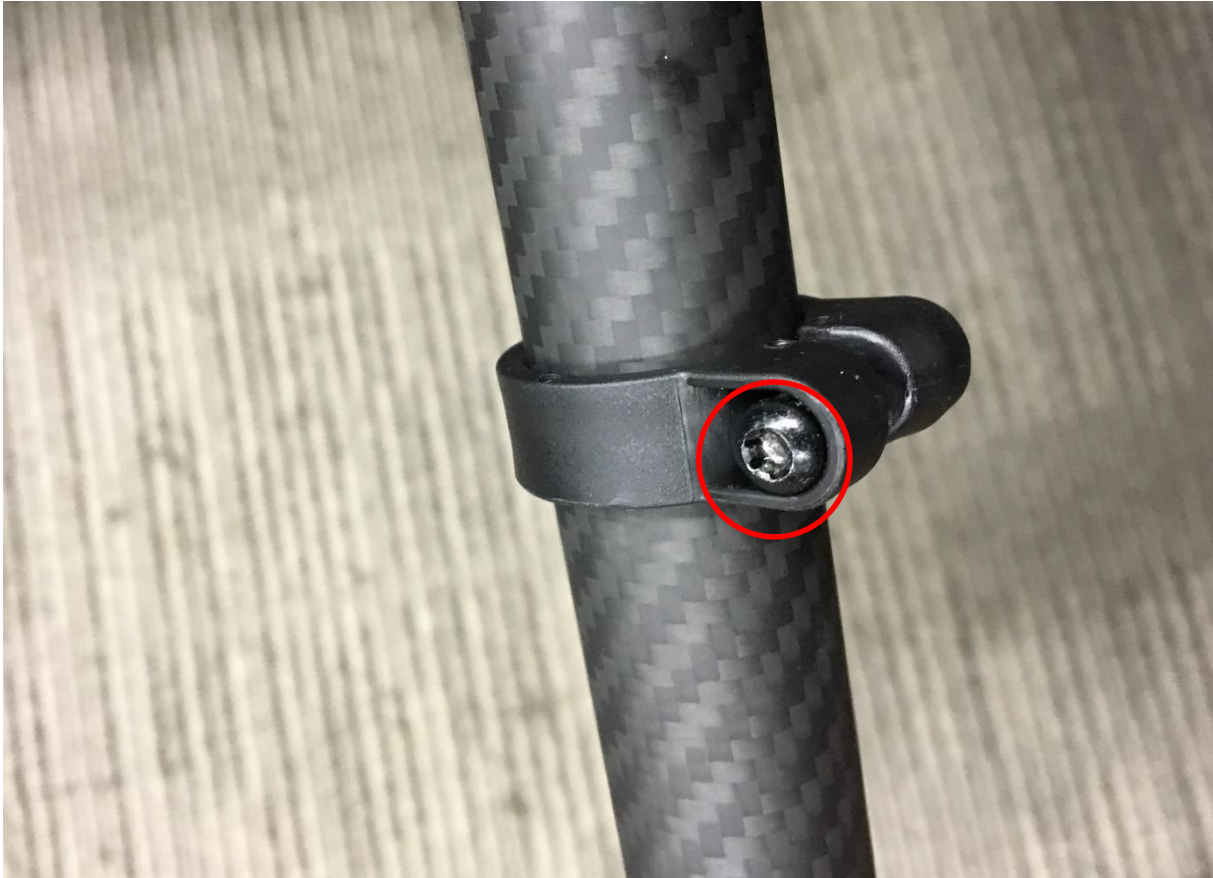
- 2. Remove the screw and take retaining ring from the shaft .

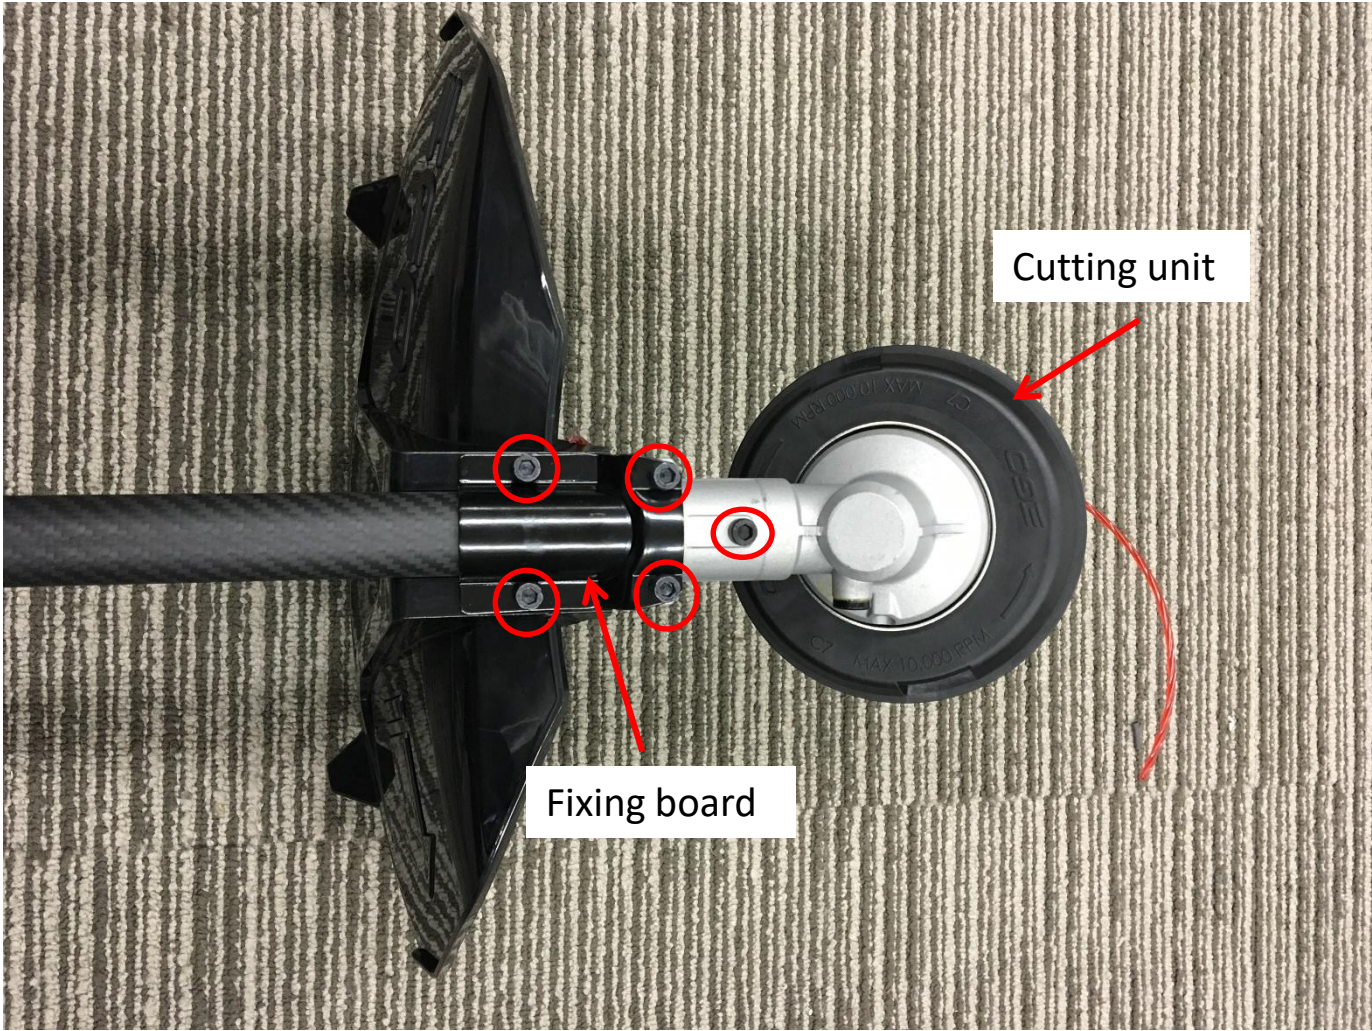
3. Loosen the five screws to separate cutting unit fixing board & guard from the shaft.

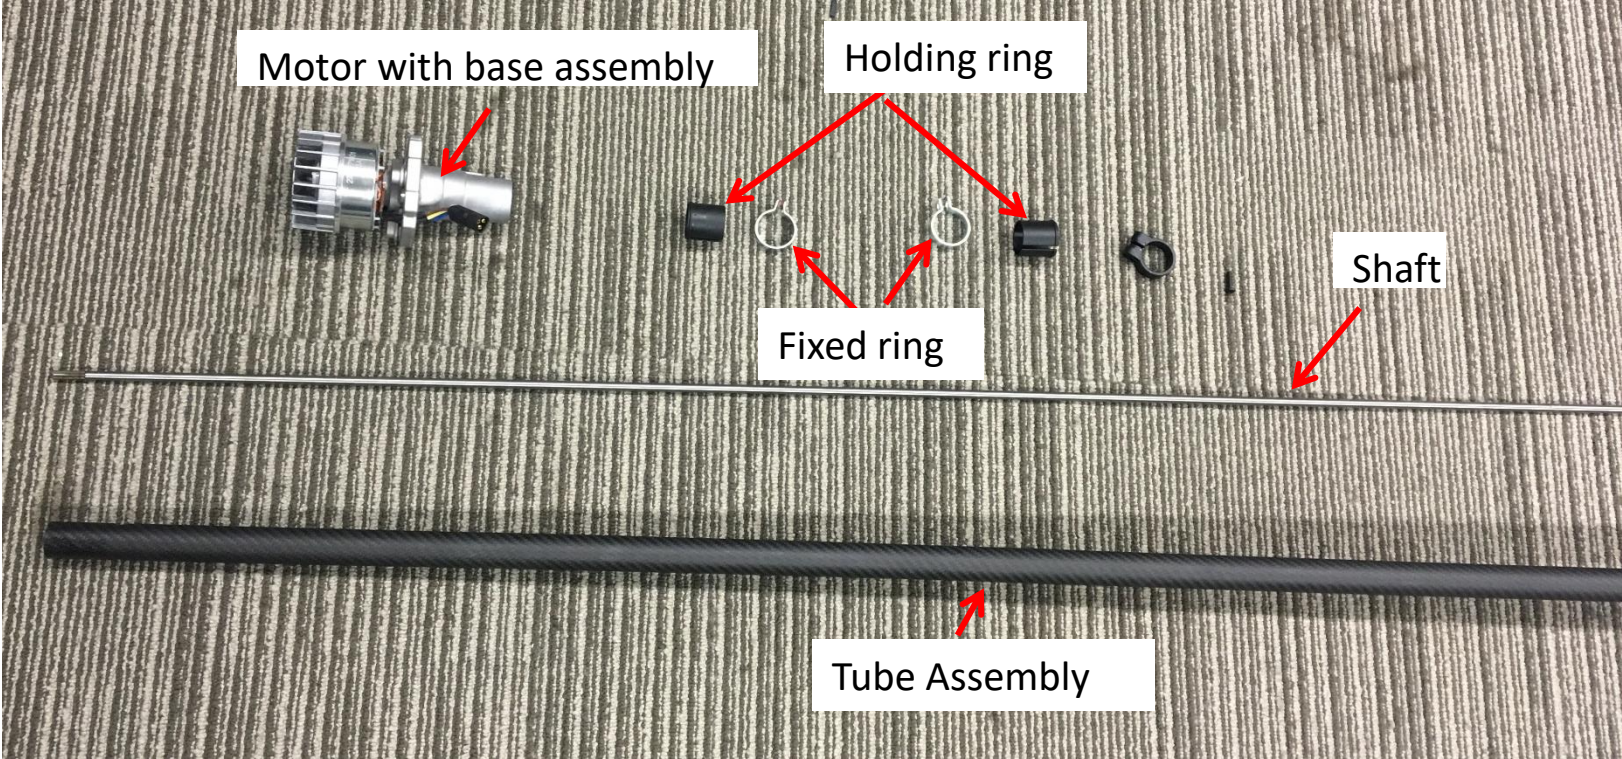
4. Pull out the shaft from the tube ASSY and replace the shaft or the tube ASSY with a new one.
